Elliott Home Inspections, Inc.

Property Inspection Report

123 Main St, Your Town, CO 12345

Date of Inspection: 1/1/1 Time: 9:00 AM

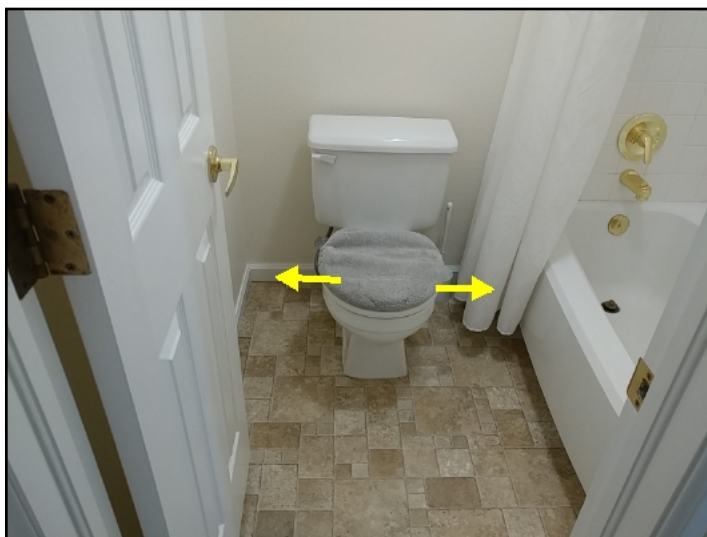
- Operated when tested. No deficiencies observed except as noted.
- **A loose toilet and/or loose/soft sub-flooring was observed. This can indicate damage to the sub-flooring beneath the fixture and floor covering. This condition is not visible or fully accessible to the inspector without destructive investigation. Client is advised to seek further review by a licensed plumbing contractor prior to closing for repairs/replacement as required.**

Toilet: East twin bedrooms bath, is loose. Recommend repair by licensed plumber.

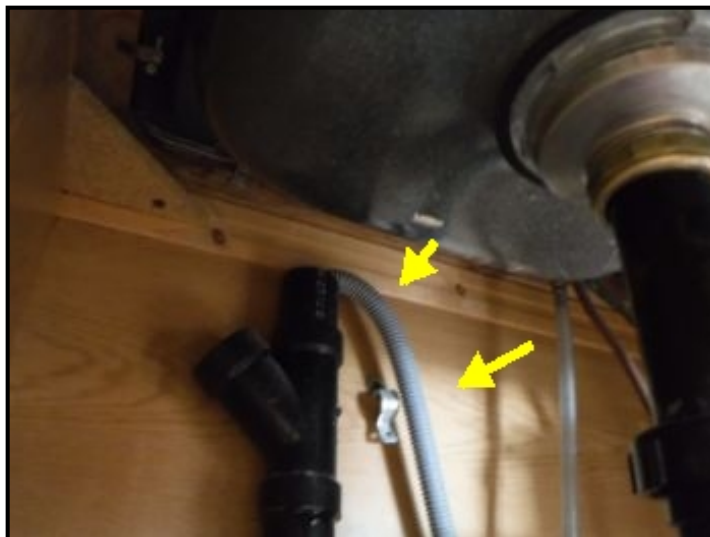
Recommend securing dishwasher loop drain line, under sink cabinet.

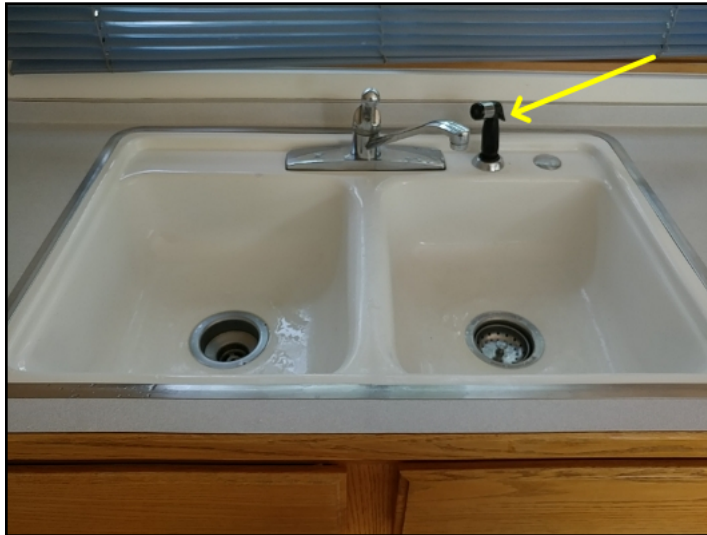
Sprayer is nonfunctional.

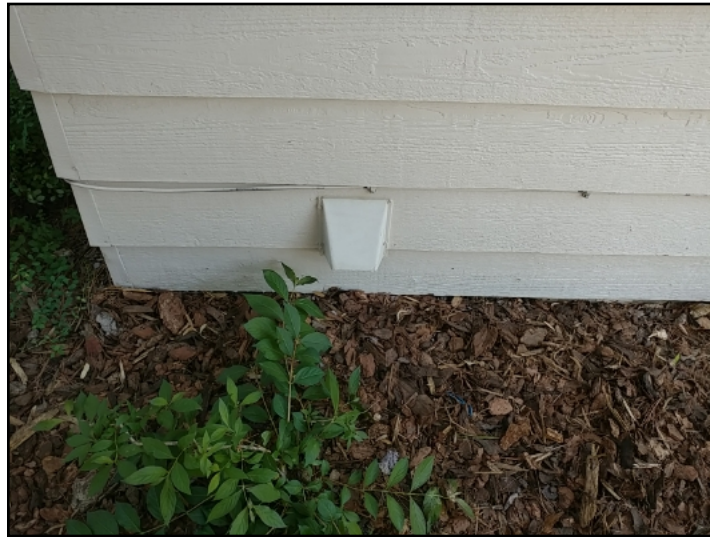
Dryer vent. Functional.

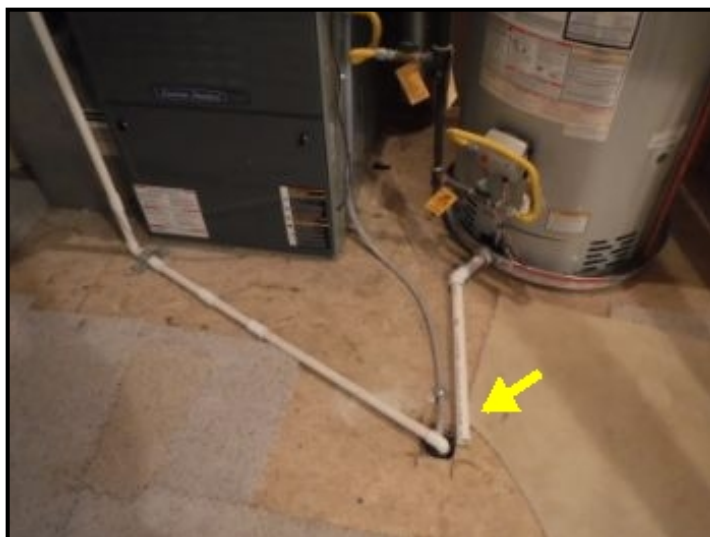
PVC should be directed into ABS drain.

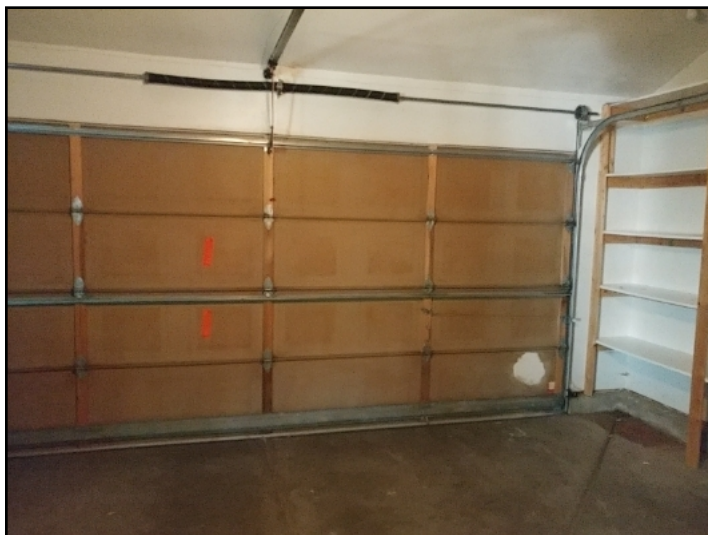
Photo safety reverse feature works but pressure reverse is either not a feature of the opener or needs to be adjusted.

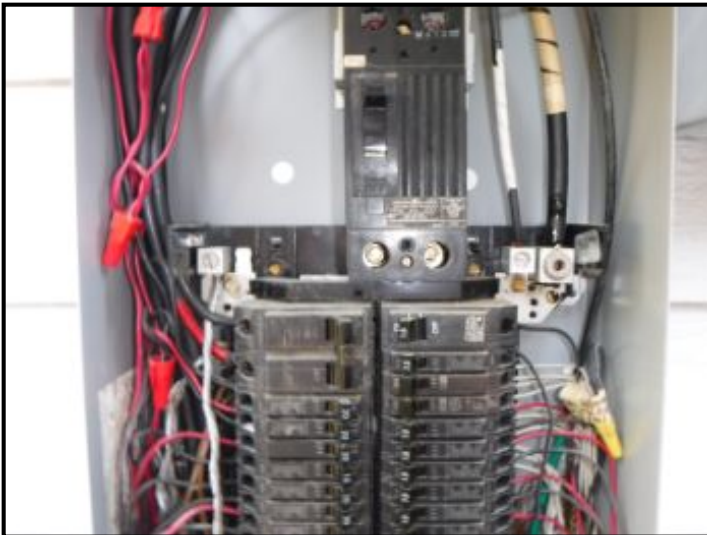
No major system safety or function concerns noted at time of inspection at main panel box.

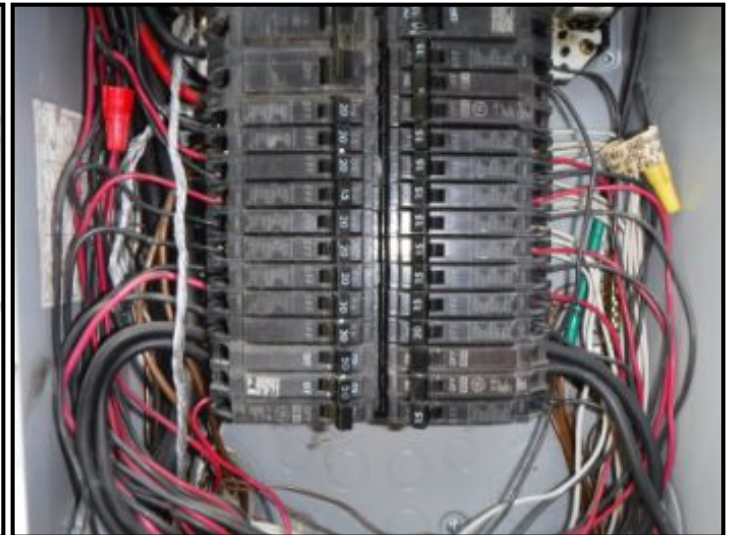
No major system safety or function concerns noted at time of inspection at main panel box.

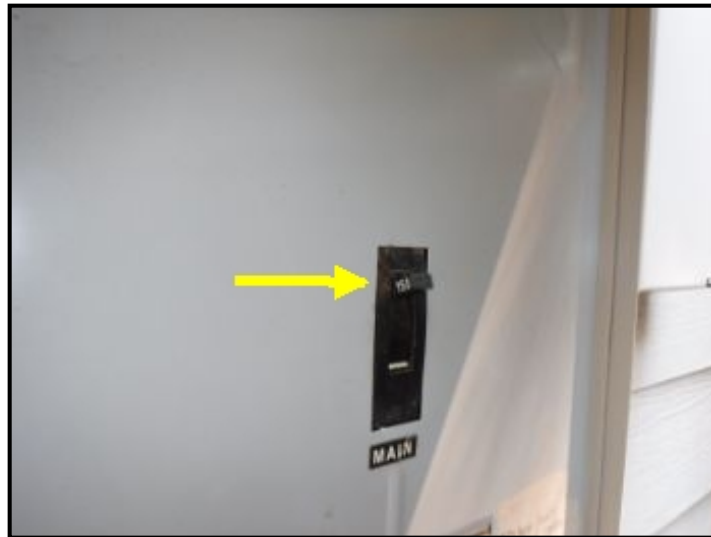
150 amp

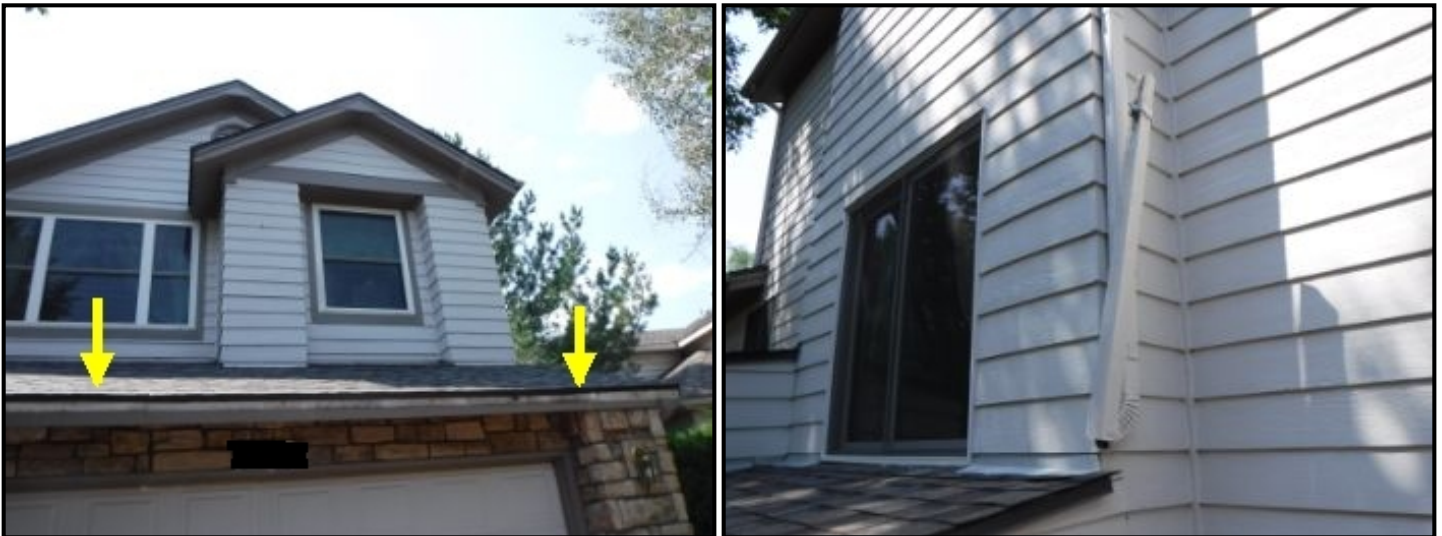
Gutter missing over entranceway to garage;
potential ice hazard.

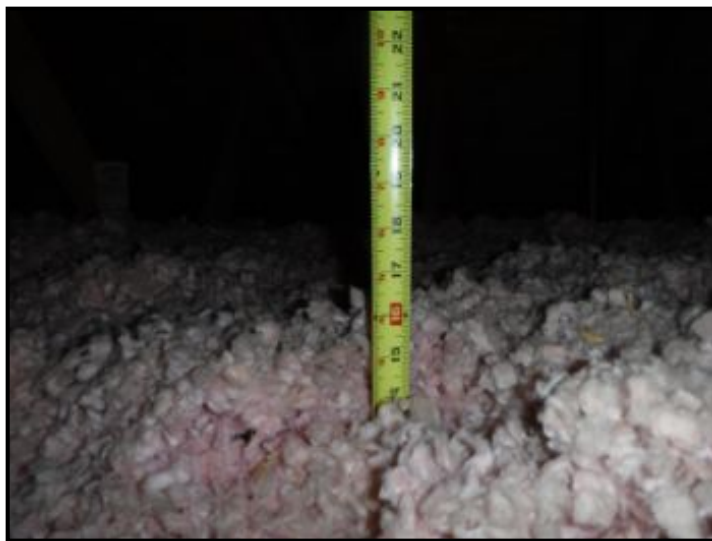
14" - 16" depth.

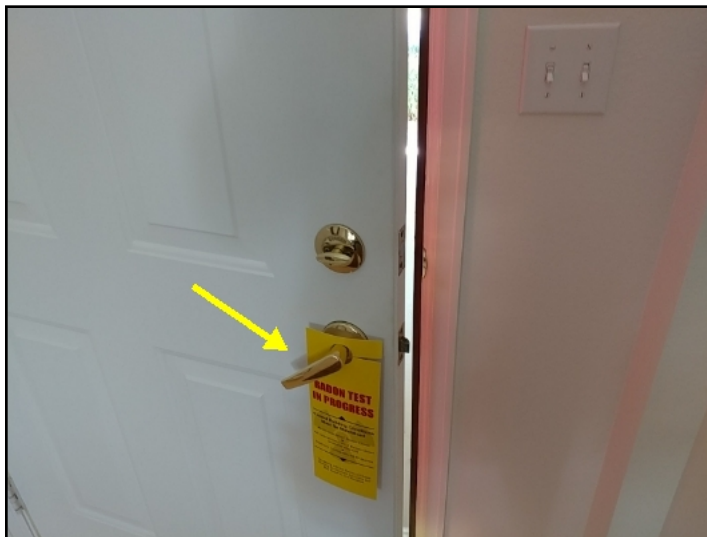
Front door lockset: adjust/replace or repair.

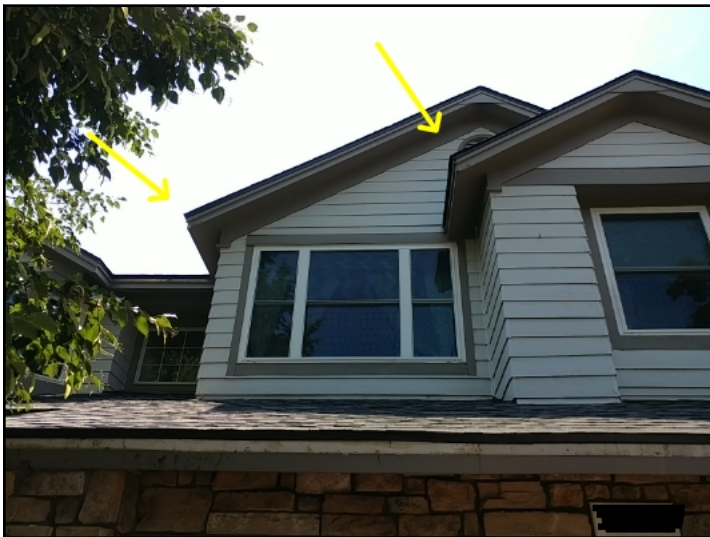
Soffit Corners could use some paint. Front of house.

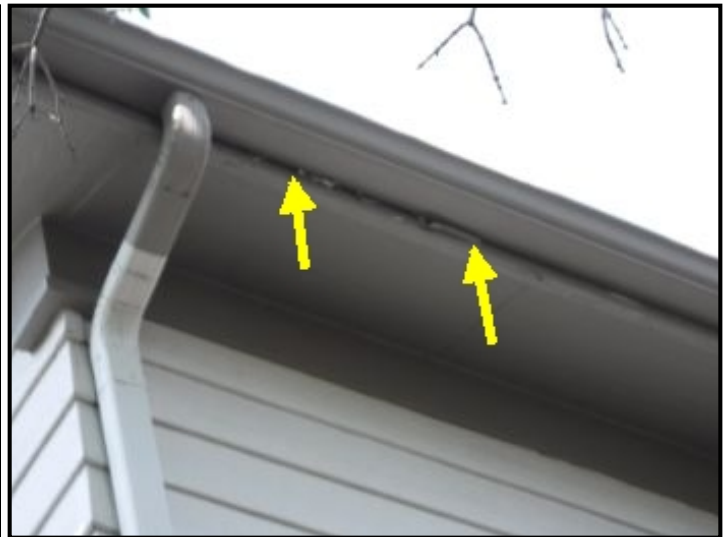
Peeling paint observed, suggest scraping and painting as necessary.

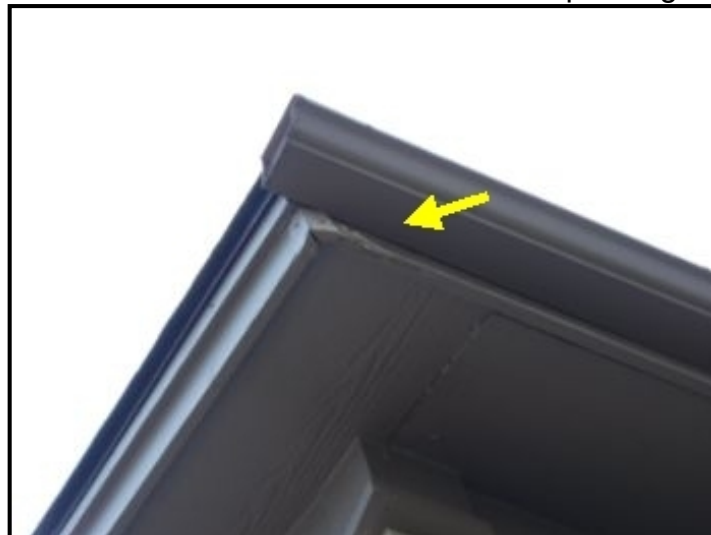
Peeling paint observed, suggest scraping and painting as necessary.

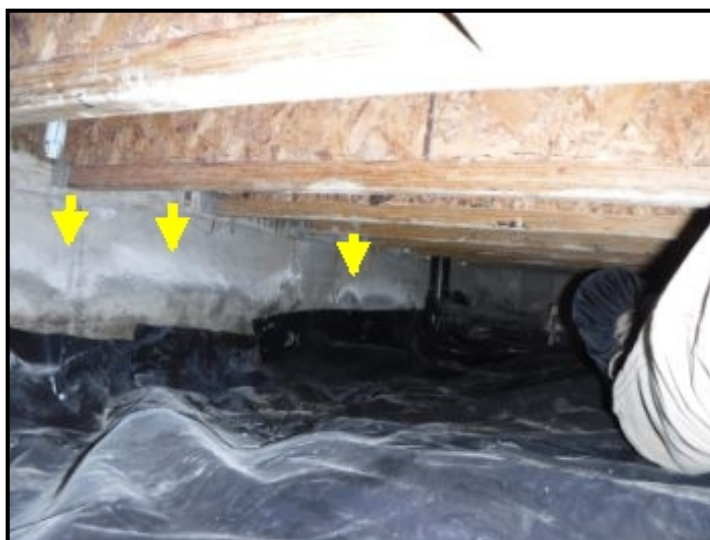
Efflorescence observed; this is a mineral deposit left behind from exterior water infiltration.

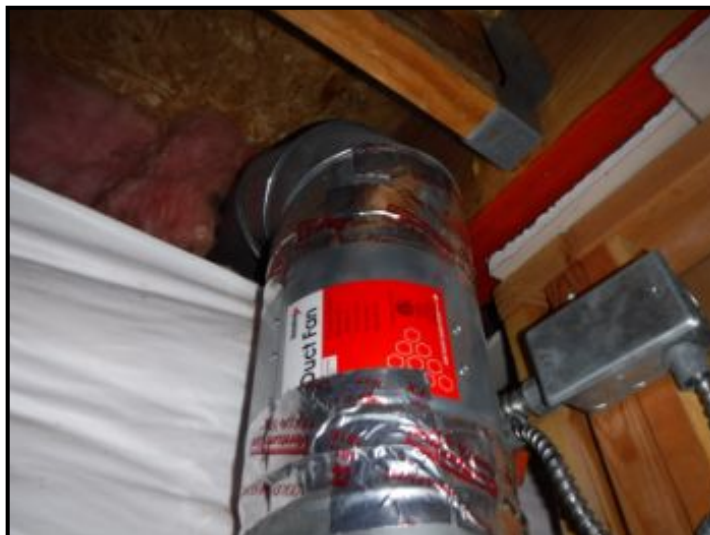
Continuously running ventilation fan noted in Sump Pump closet.

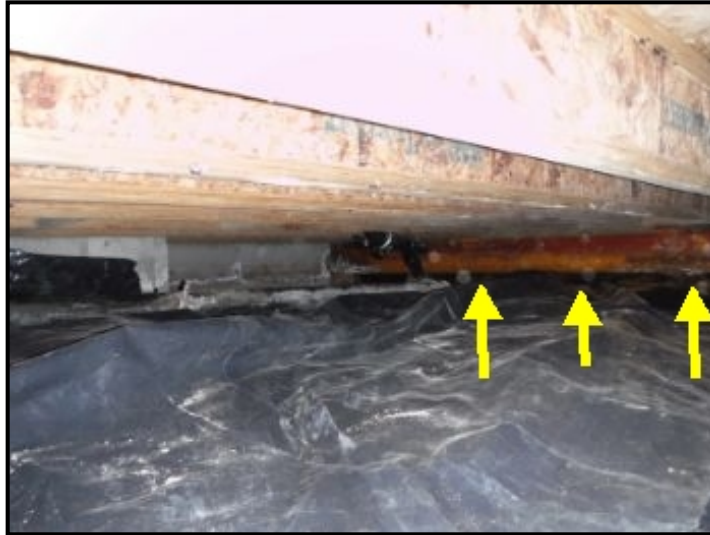
Steel I-Beam is rusted.

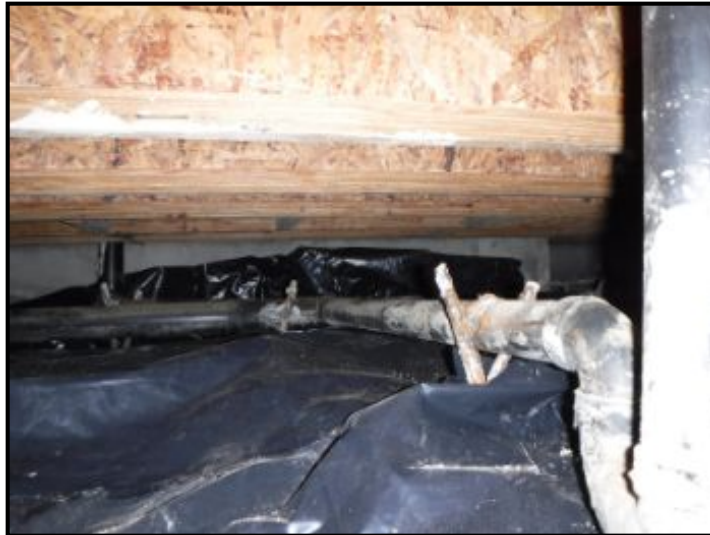
ABS drain pipes need strapping.

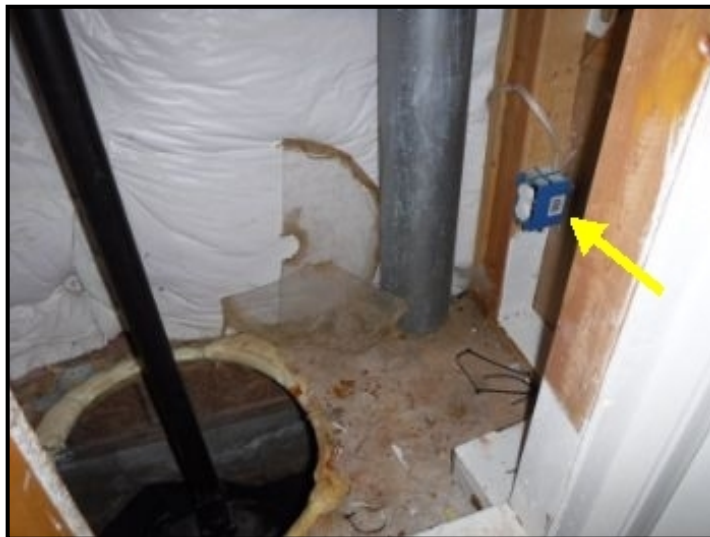
Outlet missing cover plate.

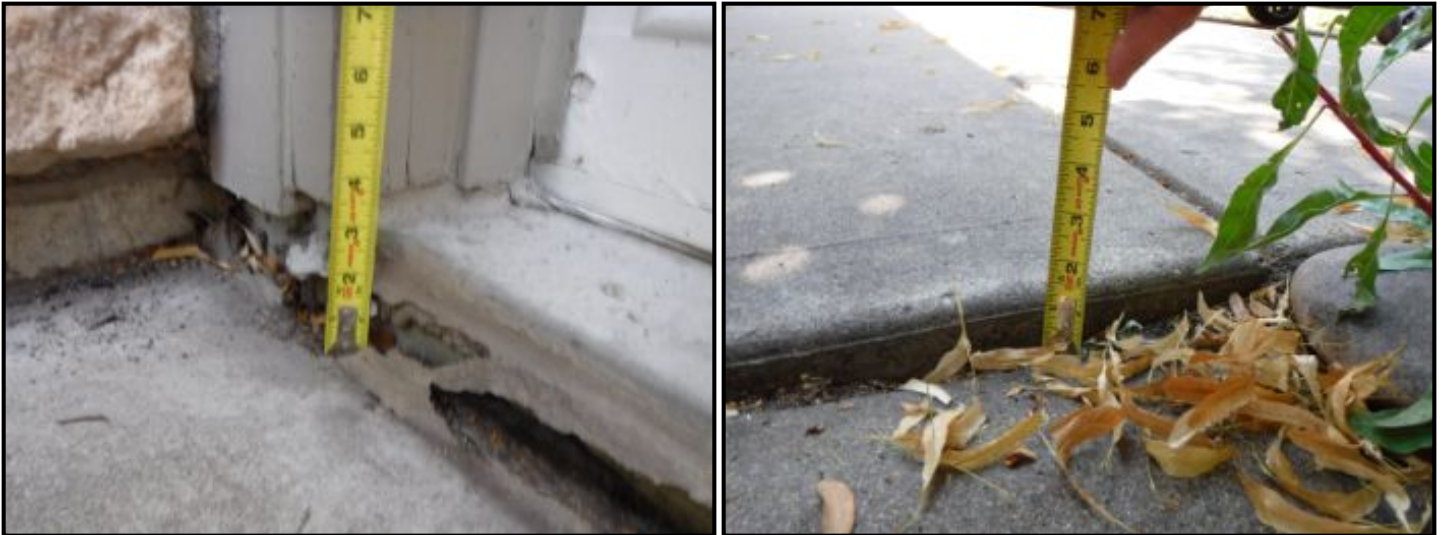
- Uneven slabs at the driveway. This is a potential tripping hazard. Recommend repair and or replacement of the displaced walks.

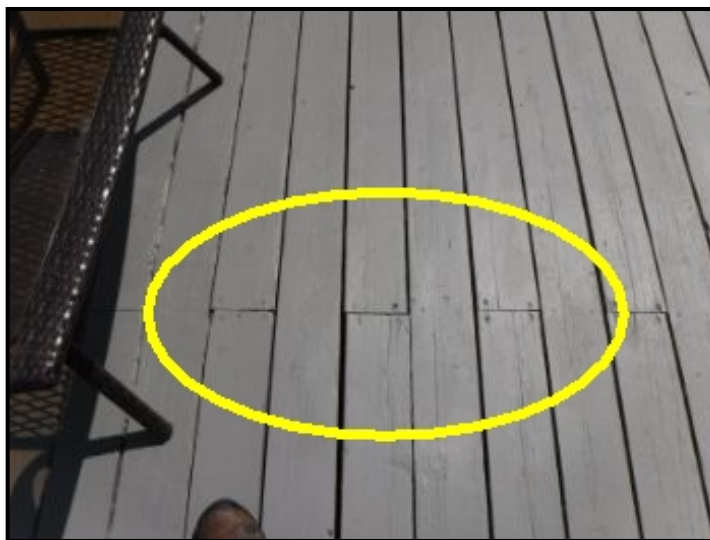
Some deck boards need securing.

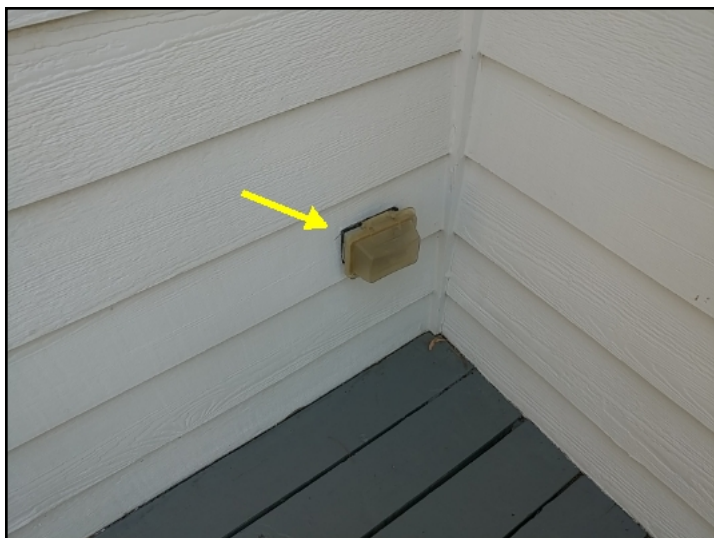
Outlet is loose. West deck.

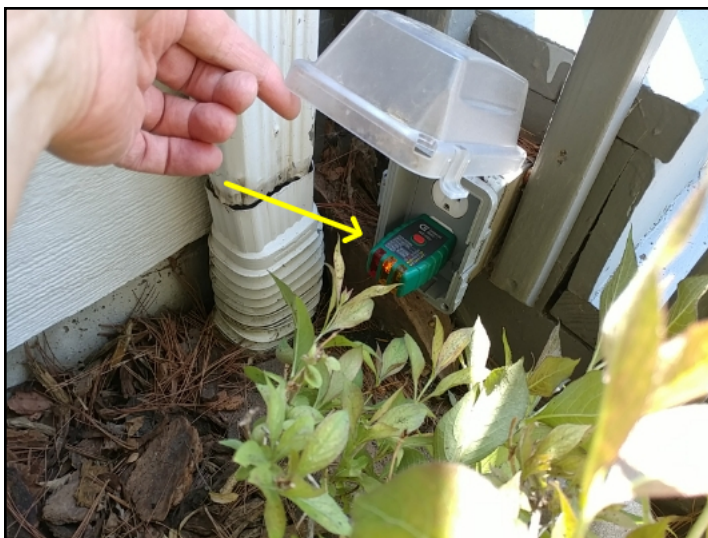
West side of deck by stairs: Outlet has open ground recommend review by qualified electrician.

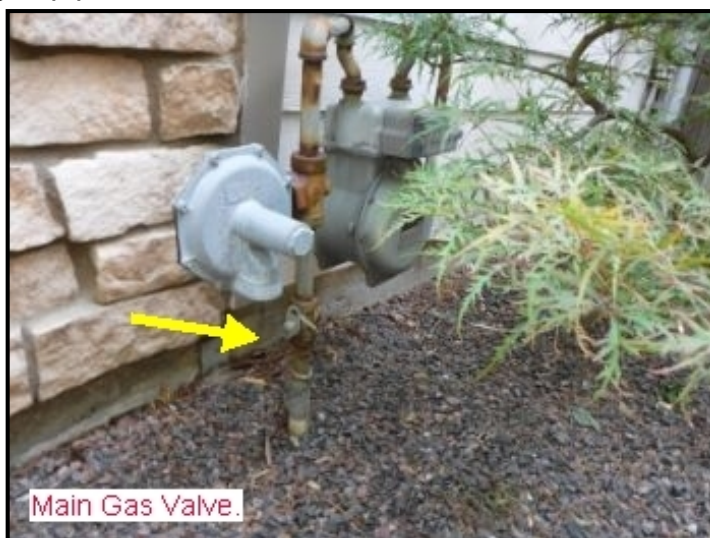
Recommend painting gas pipes to deter rust.

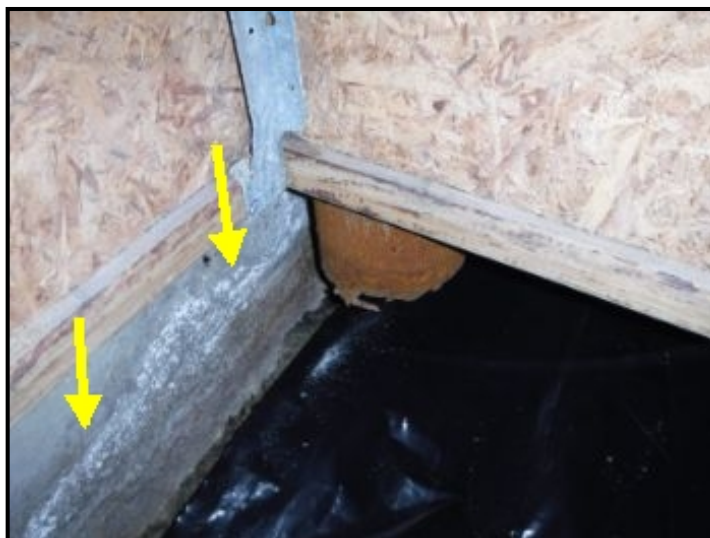
Evidence of past water penetration observed.

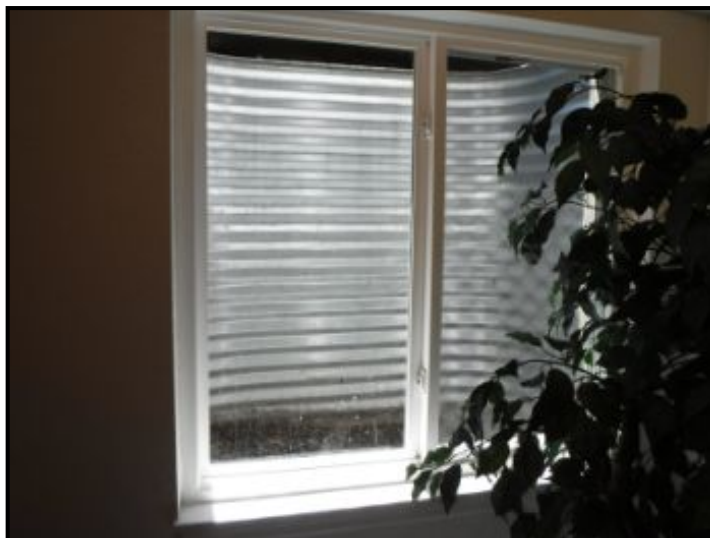
Install ladders as needed in window wells.

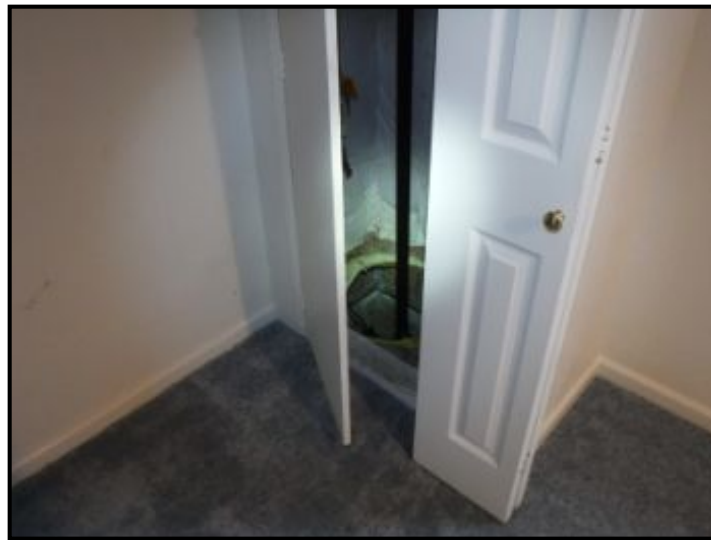
Access is not secured. Hazard to children and pets.

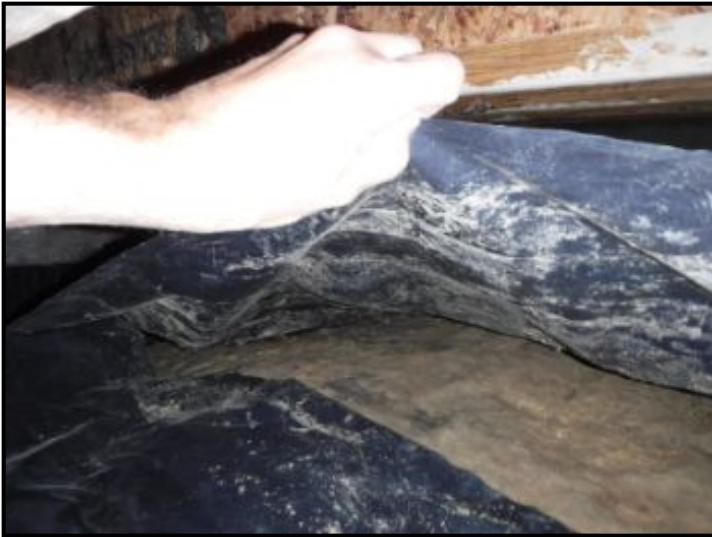
Vapor barrier not sealed at seams or perimeter.
Recommend review and repair by qualified contractor.

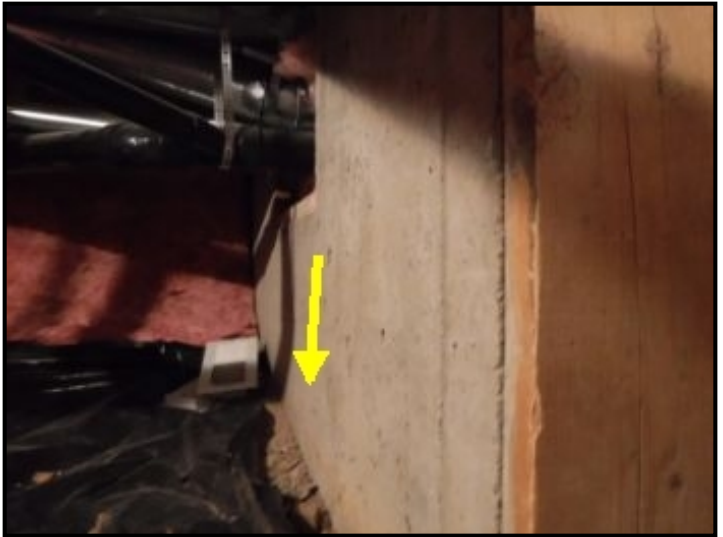
Vapor barrier not sealed at seams or perimeter.
Recommend review and repair by qualified contractor.
