# *Elliott Home Inspections, Inc.*

## Property Inspection Report

123 Any Street, Anytown, CO 00000

Date of Inspection: 1/1/2025 Time: 09:30

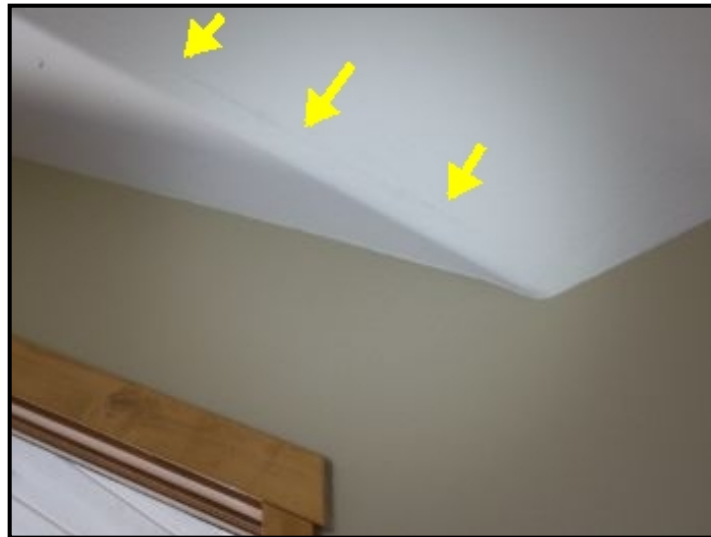
- **Small crack in the ceiling finish was noted above the main entry door, parallel to the drywall bead.**

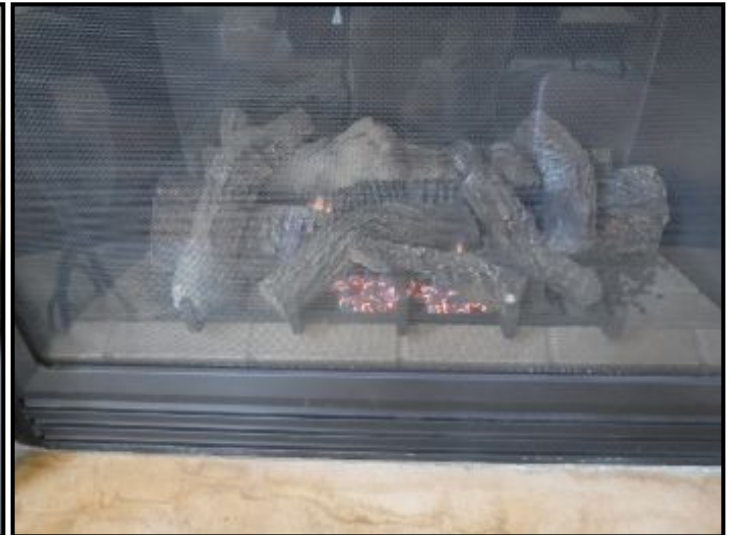
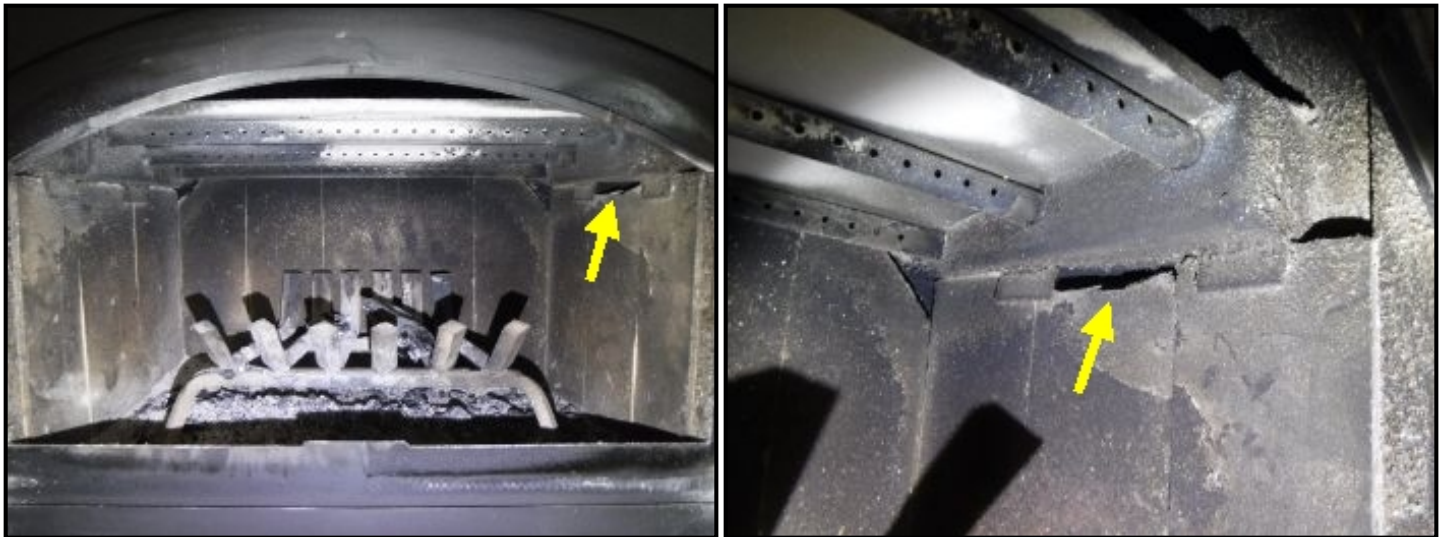
- **Cracked/damaged fireplace panel. Recommend repair replace as needed.**

Cracked/damaged fireplace panel. Recommend repair replace as need.

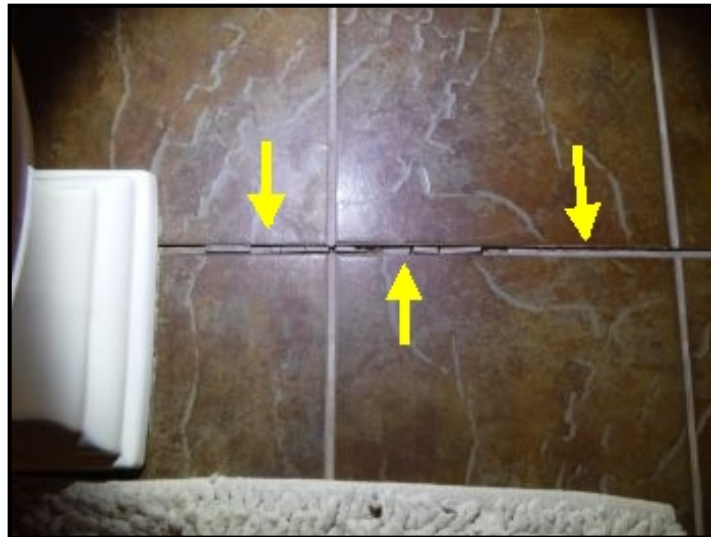
- Lower level, south bathroom floor tile, missing/cracked grout noted in front of toilet.

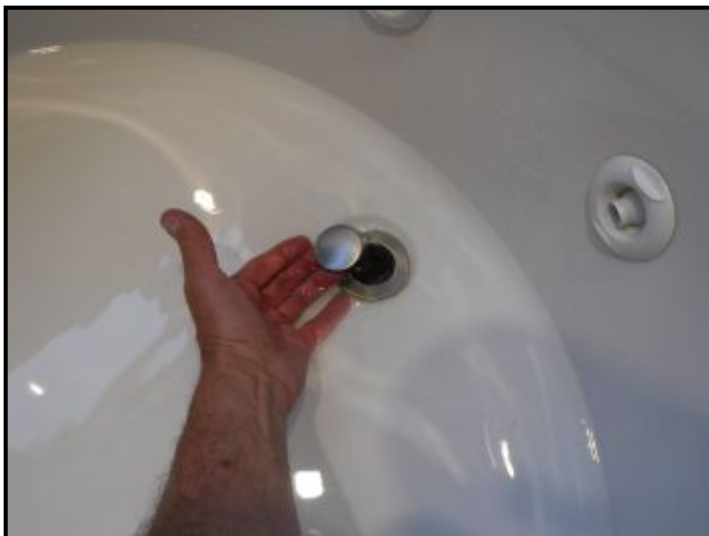
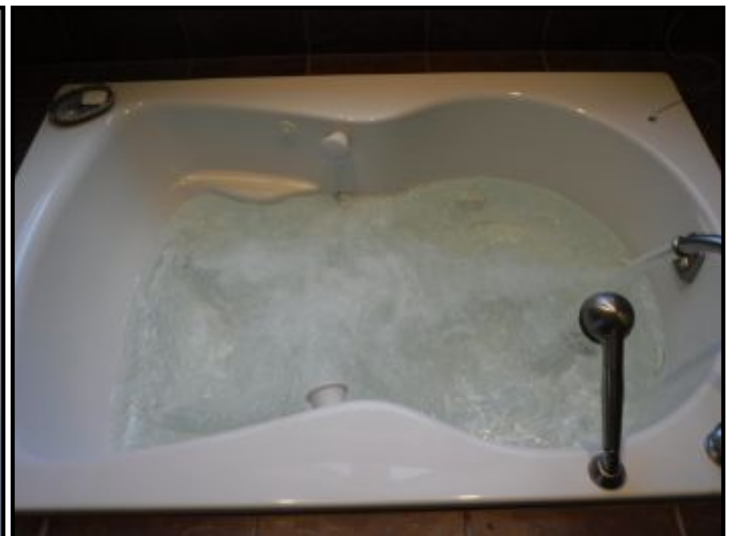
Whirlpool tub stopper was damaged.

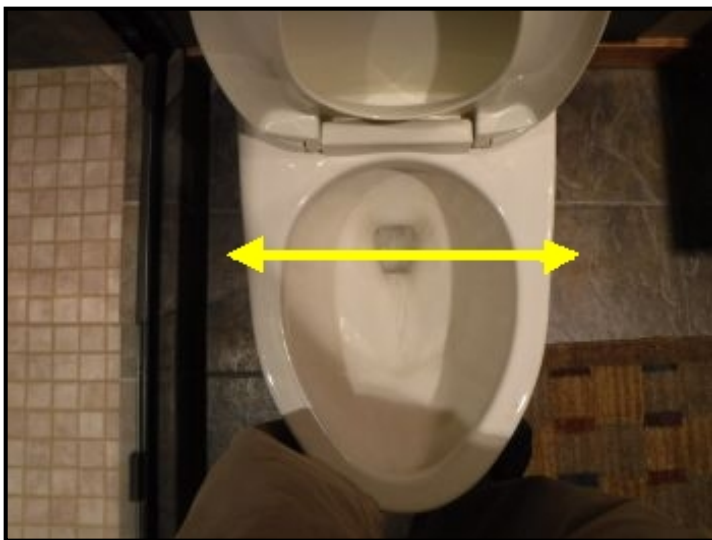
Upper level, hall bathroom toilet was loose.  
Mounts needed to be addressed.

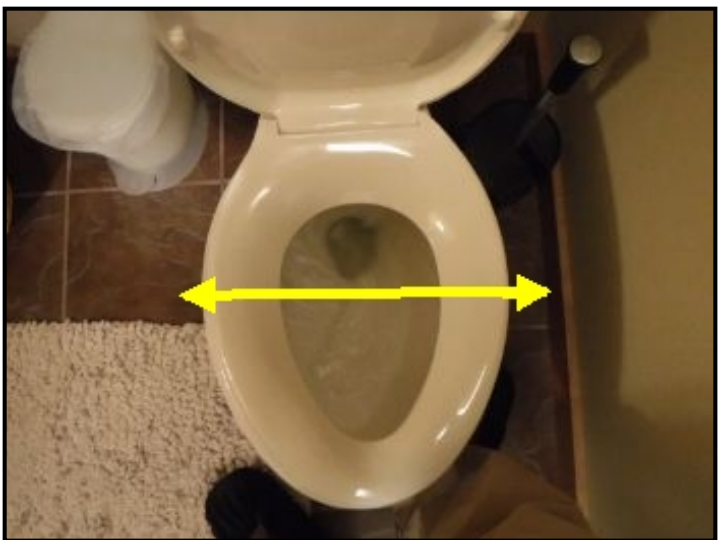
Lower level, south bathroom, toilet was loose.  
Mounts needed to be addressed.

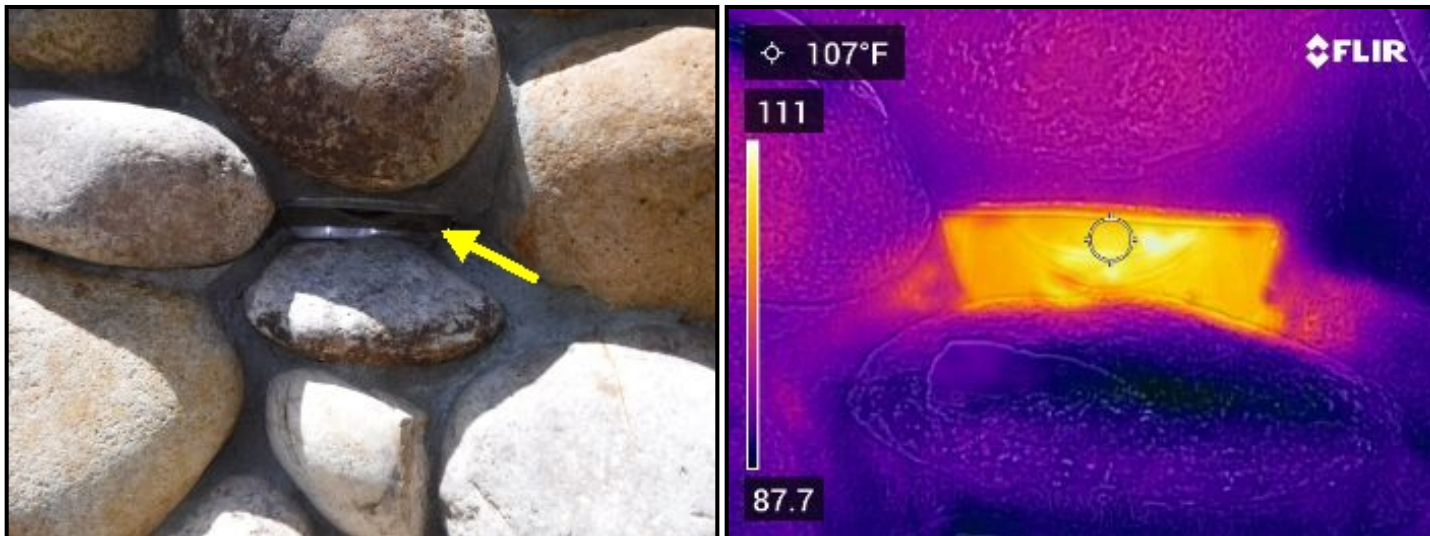
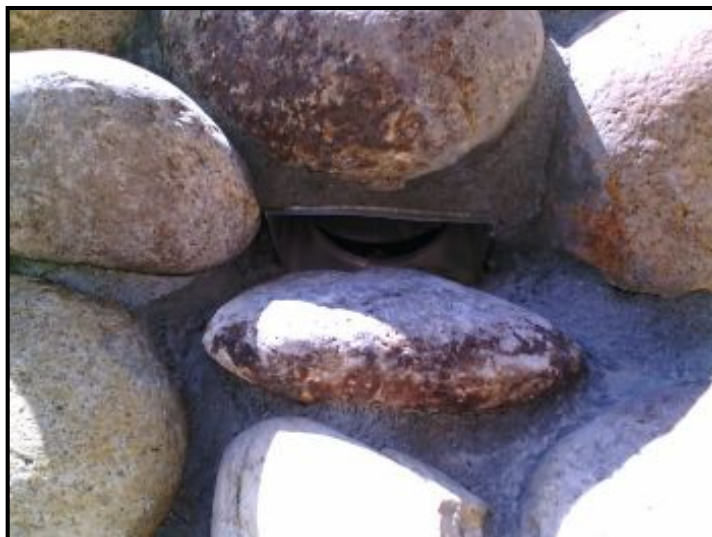
- Recommend having dryer vent cleaned by a professional.
- The dryer vent hood was obstructed by stone veneer.

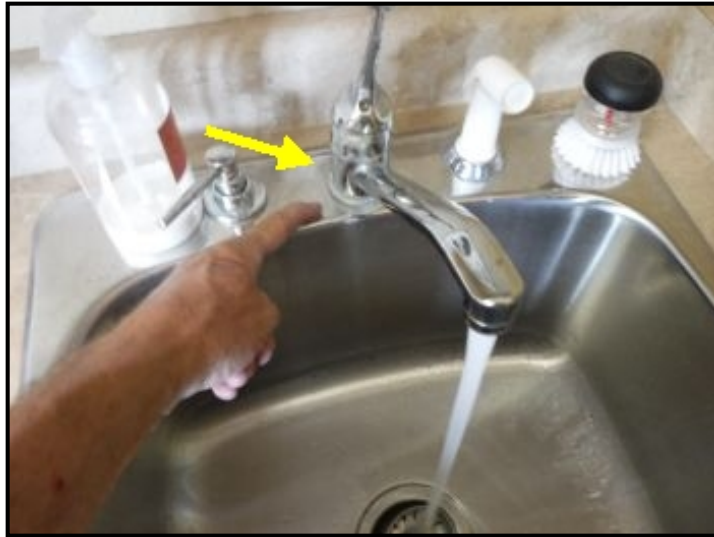
- **SUPPLY:**
- The laundry sink faucet was loose.

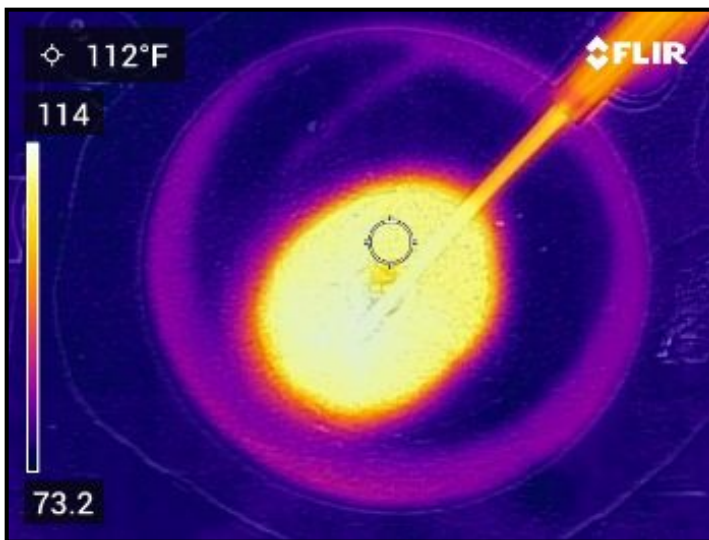
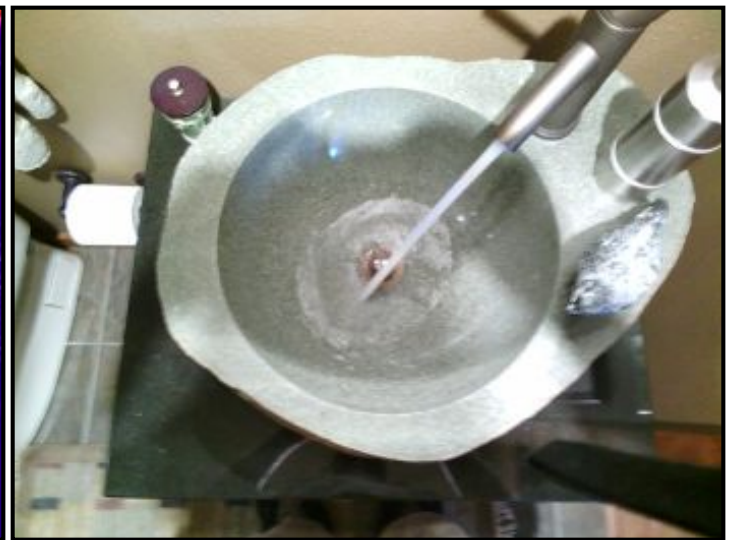
- Water temperature observed to be: 114 degrees F. Recommended temp should be set at 118-122 degrees F to prevent scalding, extend water heater life, and improve energy efficiency and conservation.

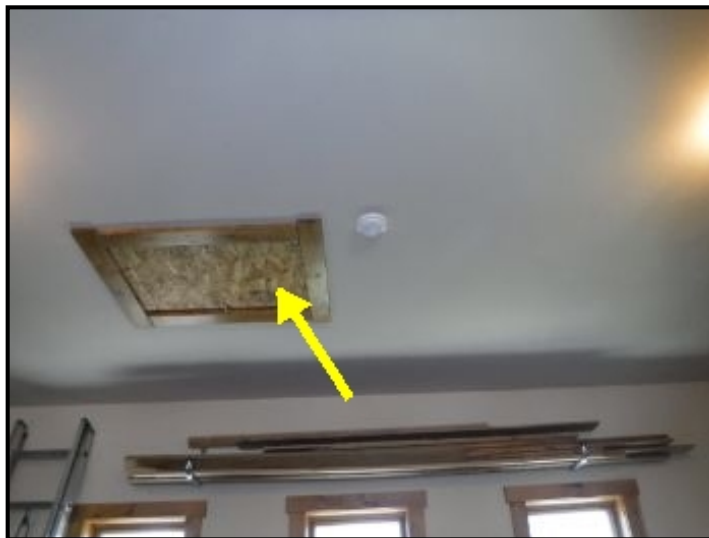
Attic access panel was not constructed to meet modern fire safety standards.

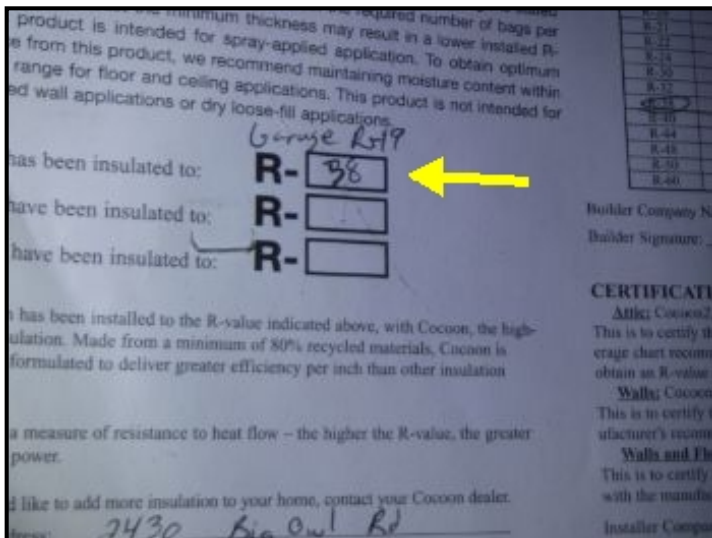
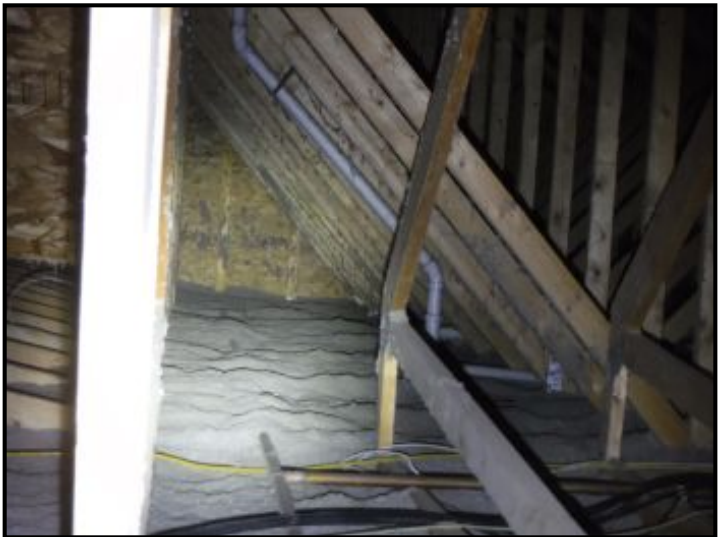
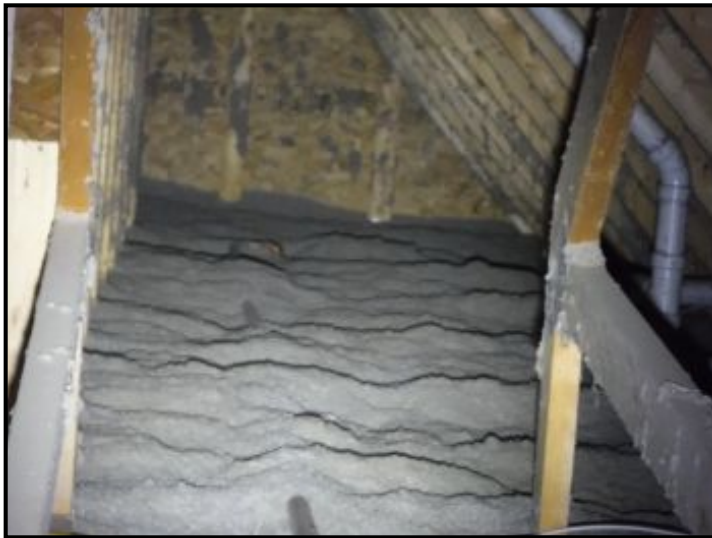
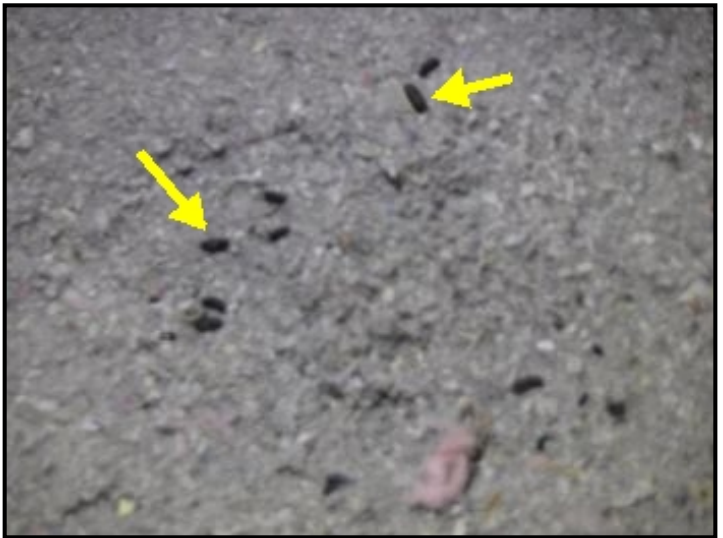
- Insulation appeared adequate.
  - **Vermin activity observed in the attic. Vermin can damage insulation & electrical wiring.**
- Recommend a professional pest contractor evaluate for treatment.**

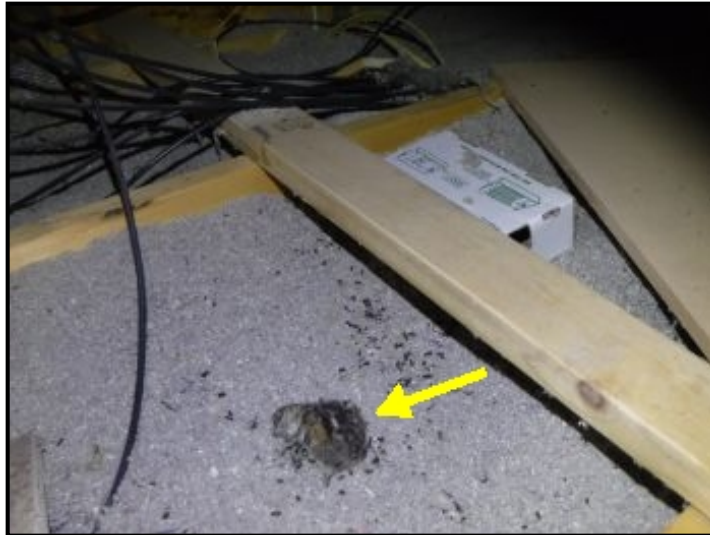
Apparent dead chipmunk noted.

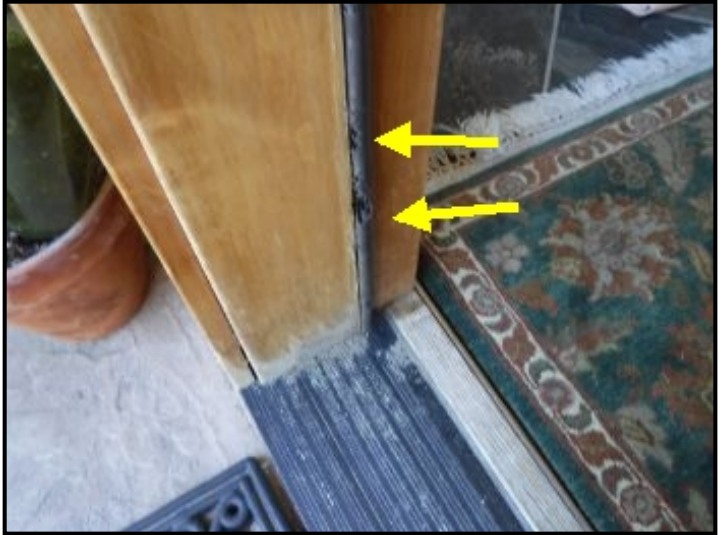
Lower level living room door was binding in the frame.

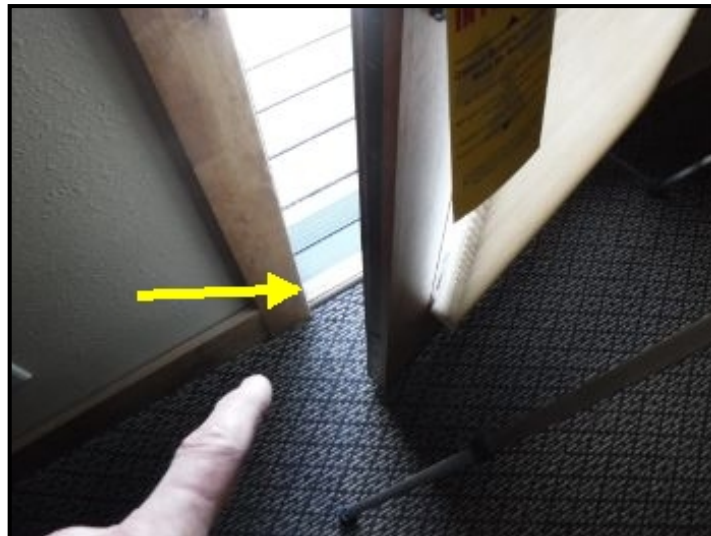
Main entry door, weather strip was damaged.

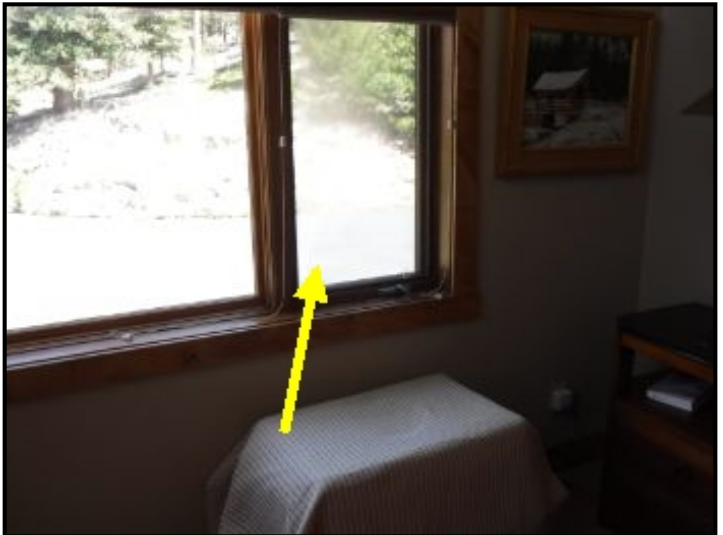
Condensation present in some double-paned windows, indicating a broken gas seal.

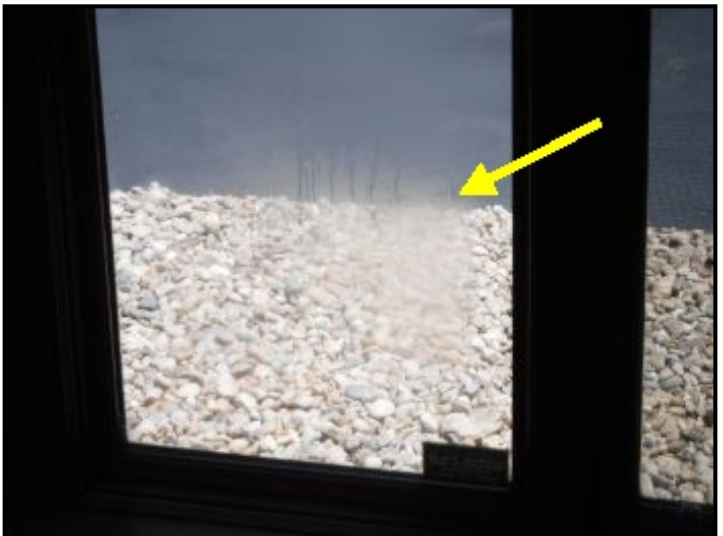
Condensation present in some double-paned windows, indicating a broken gas seal.

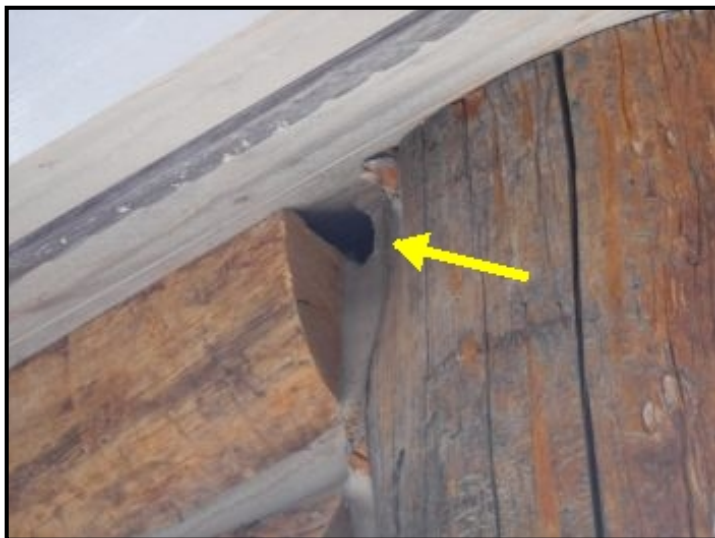
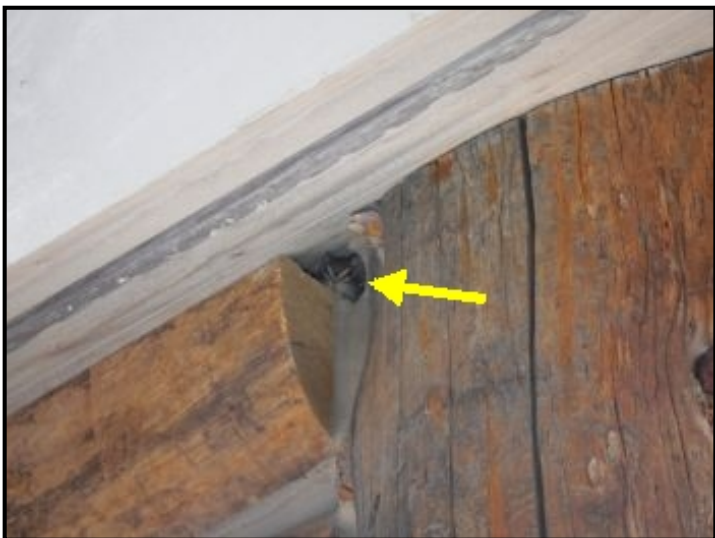
- Apparent rodent damage noted.
- Recommend sealing of all penetrations.

Chipmunk observed.

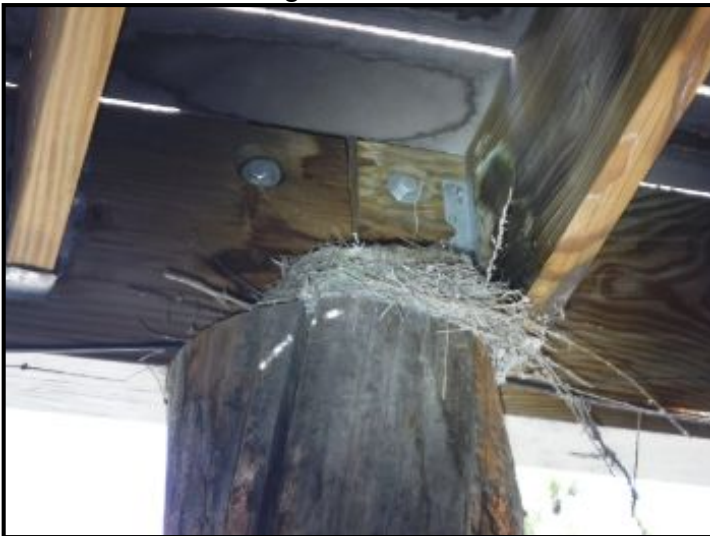
Deck boards had shrinkage.

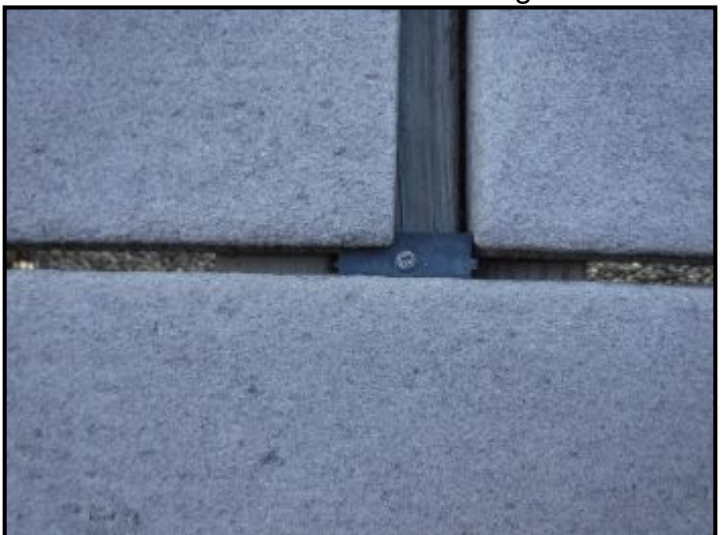
Deck boards had shrinkage.

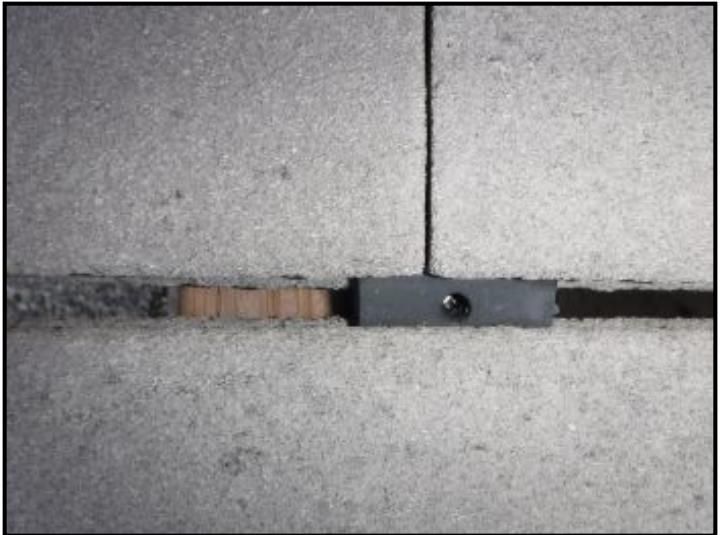
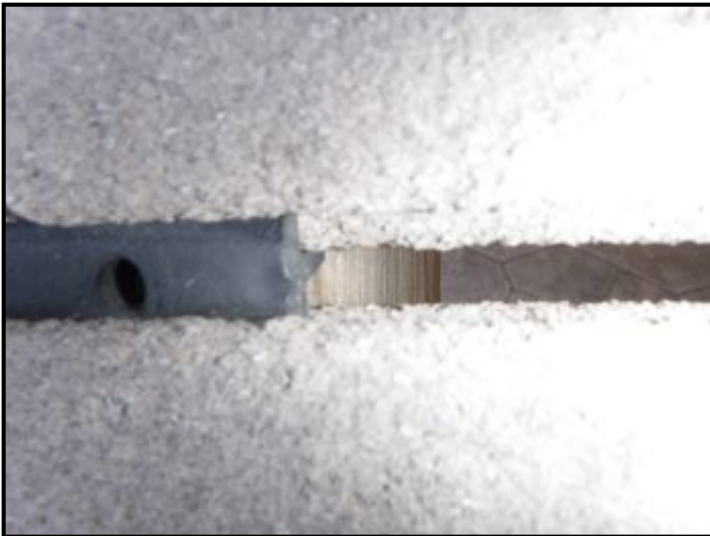
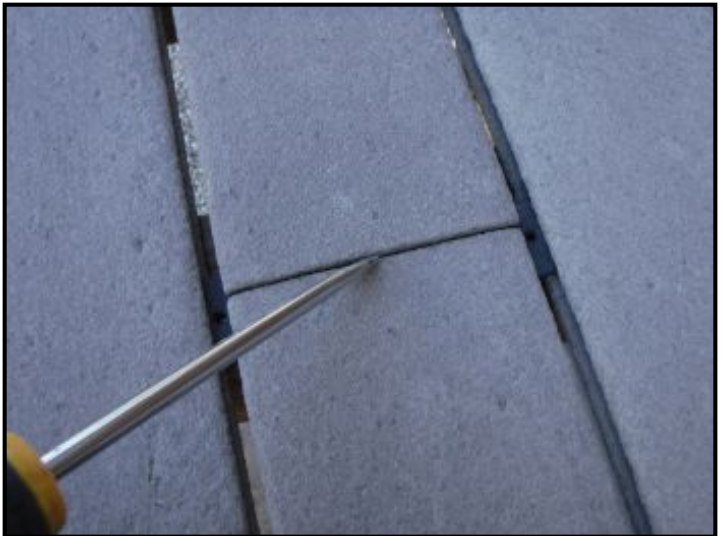
The composite deck boards were significantly deteriorated. Consider replacement of the deck surface.

Some deck boards were not secure.

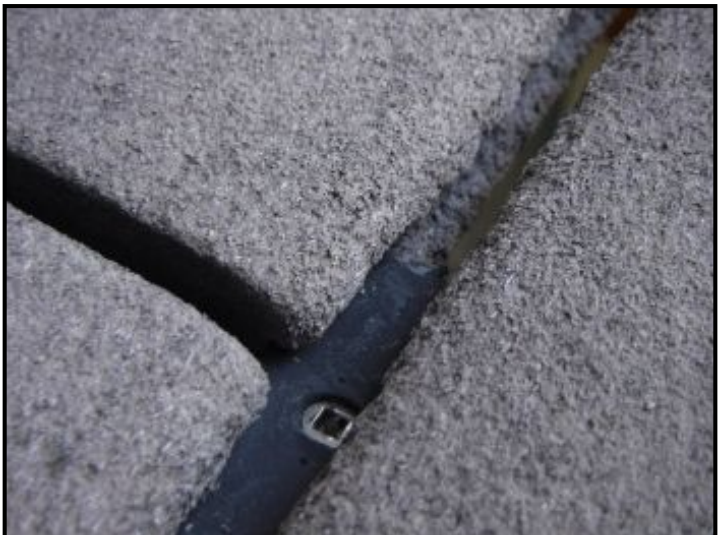
Decking was deteriorated.

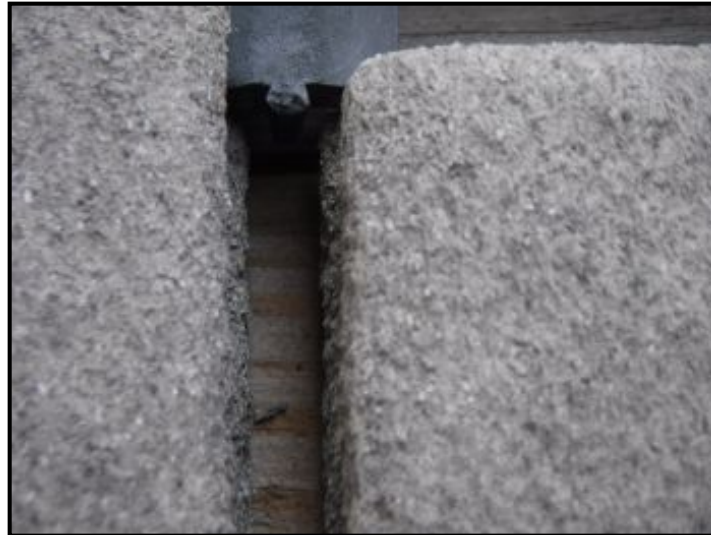
Decking was deteriorated.

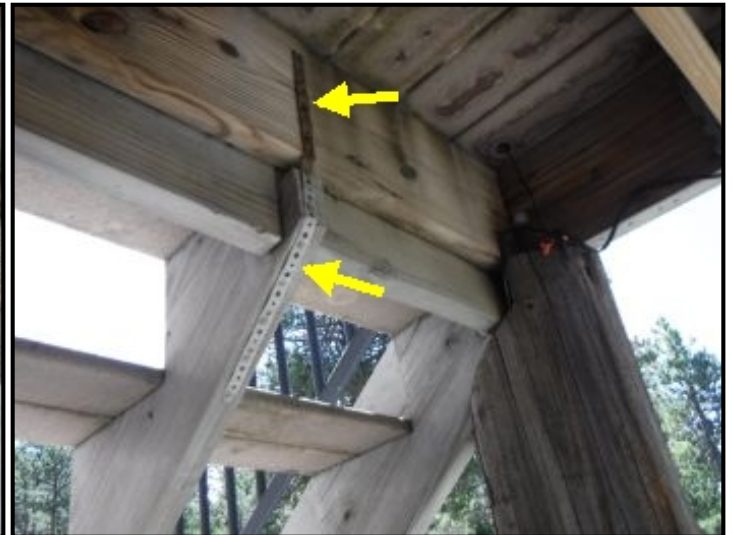
Improper attachment of stair stringers.

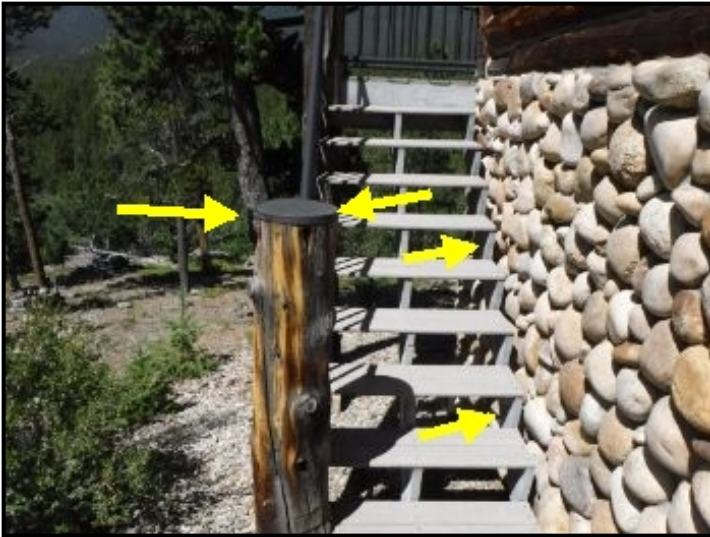
Improper attachment of stair stringers.

Safety Hazard. Stair stringers have failed/cracked through. Stair treads are loose and may fail at any time.

Recommend use of Simpson Strong-Ties or similar.

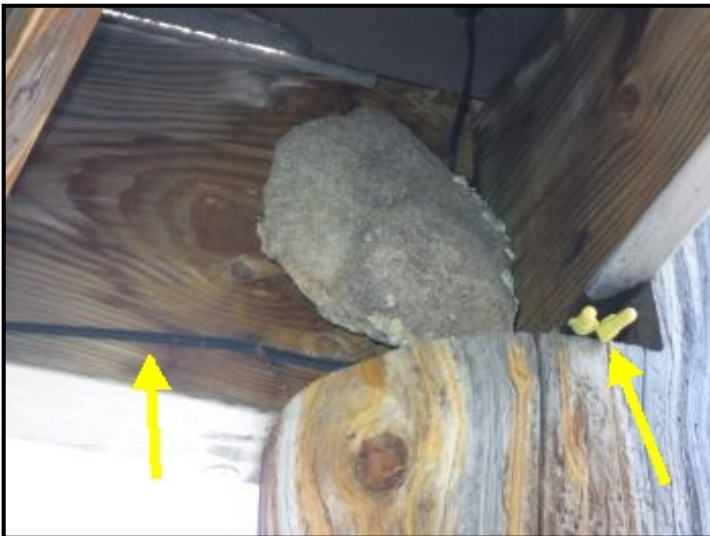
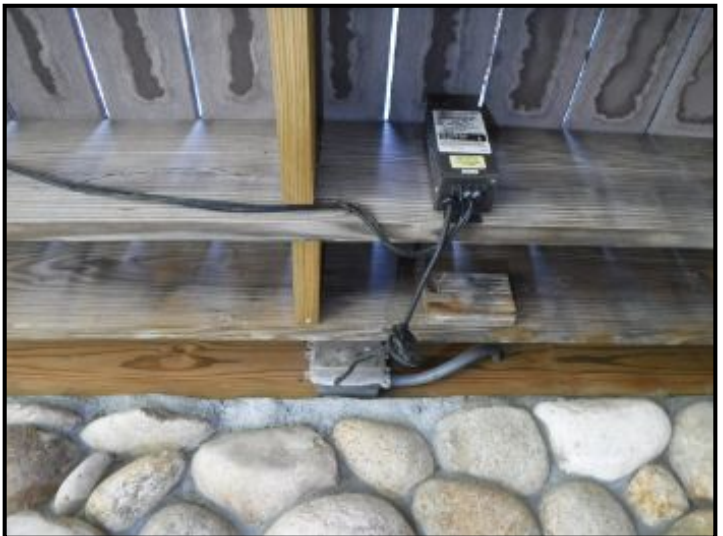
- **OUTLETS:**
- No major system safety or function concerns noted at time of inspection.
- **WIRES:**
- Connections made outside of a Junction Box, which is a potential shock or electrocution hazard.
- Extension cord used in lieu of "hard wire".
- Exterior wires should be enclosed in conduit.

Exterior wires should be enclosed in conduit.

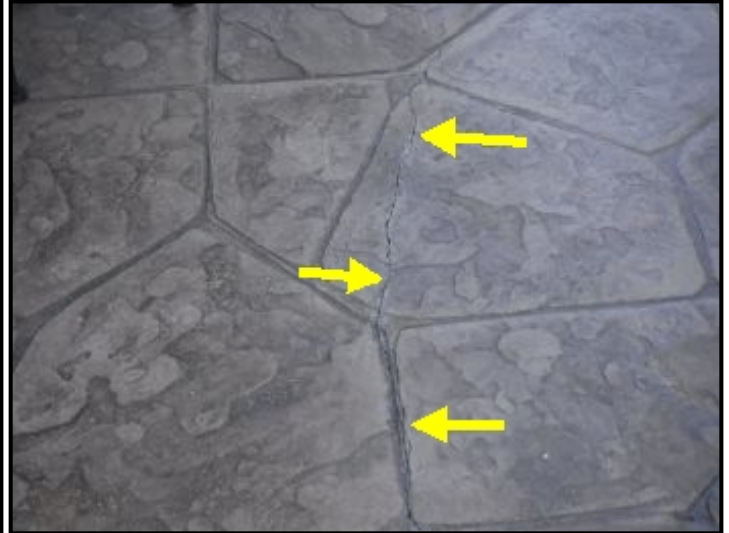
Back/west patio: Settlement cracks noted.

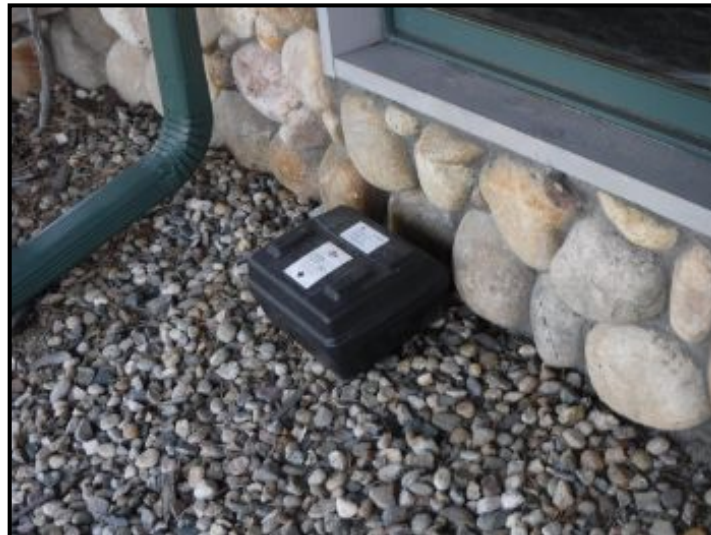
Bait boxes or traps for rodents noted.
