Elliott Home Inspections, Inc.

Property Inspection Report

123 Main St, Your Town, CO 12345

Date of Inspection: 1/1/1 Time: 9:00 AM

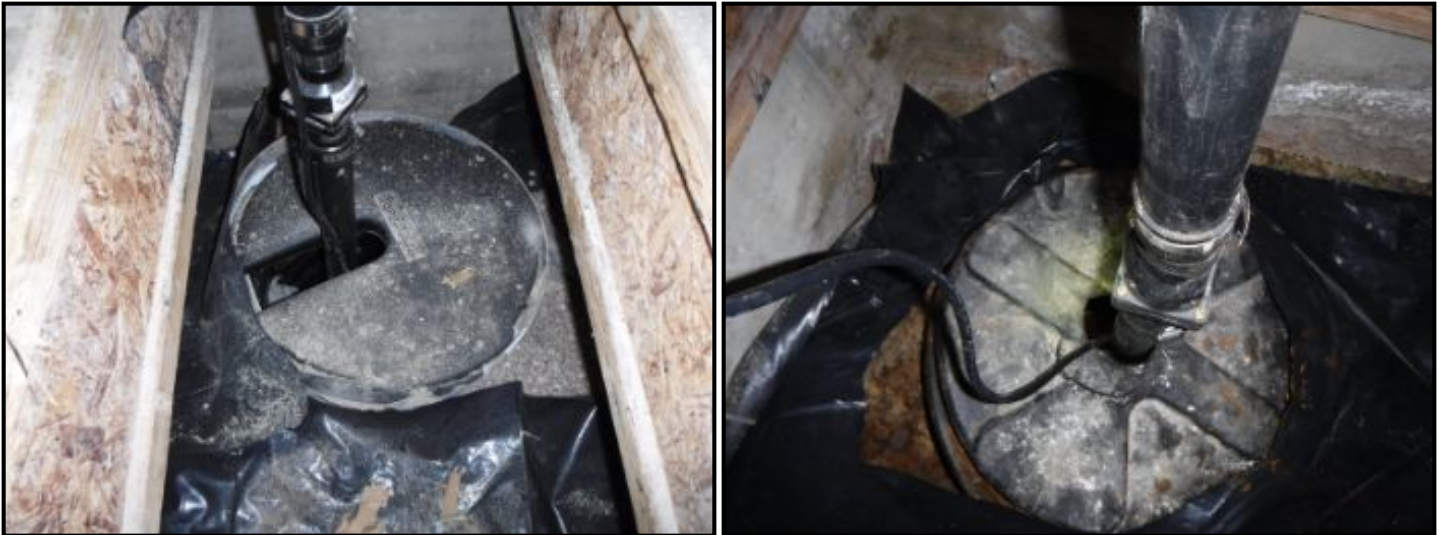
6. Sump Pump

- Recommend further review of current drainage pit system. Recommend upgrading of current pump for enhanced reliability of discharge water in case of power outage. Recommend installation of a battery backup sump pump by a qualified contractor to provide peace of mind to occupants and protection of personal belongings.

Access is not secured. Hazard to children and pets.
