# *Elliott Home Inspections, Inc.*

## Property Inspection Report

123 Any Street, Anytown, CO 00000

Date of Inspection: 1/1/2025 Time: 09:30

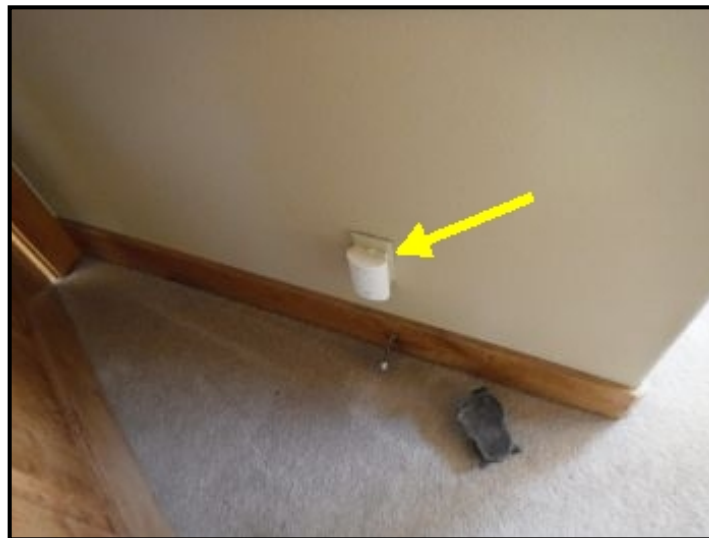
- **\*\*SMOKE DETECTORS\*\***
- Smoke detectors noted as present.
- **\*\*CARBON MONOXIDE DETECTORS\*\***
- Present at time of inspection.

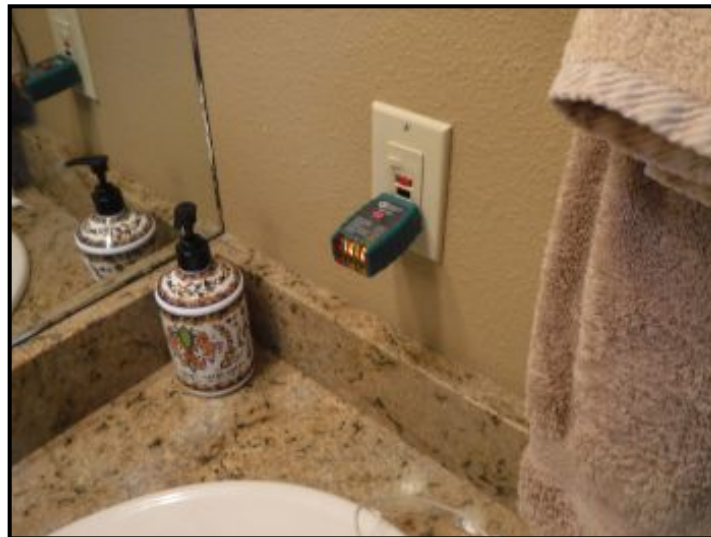
- **GFCI** was in place and operational.
- Lower level, north bathroom GFCI resets outlets in other bathrooms that do not have GFCI outlets but are on the same circuit as the basement bathroom.

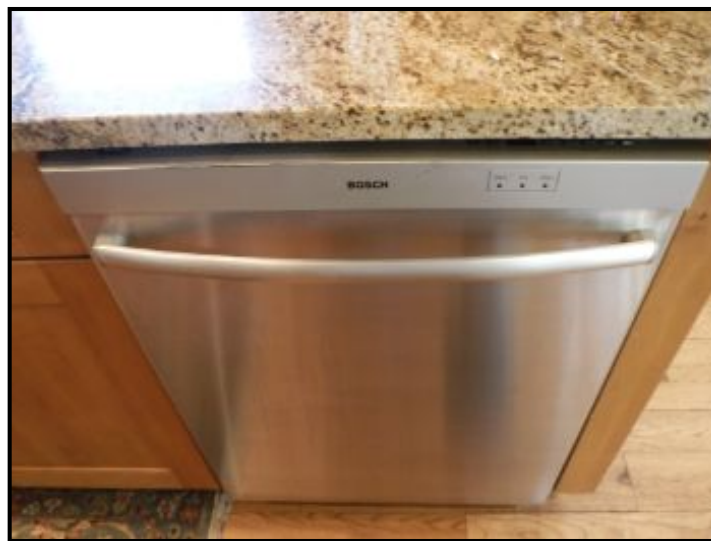
- Operated.

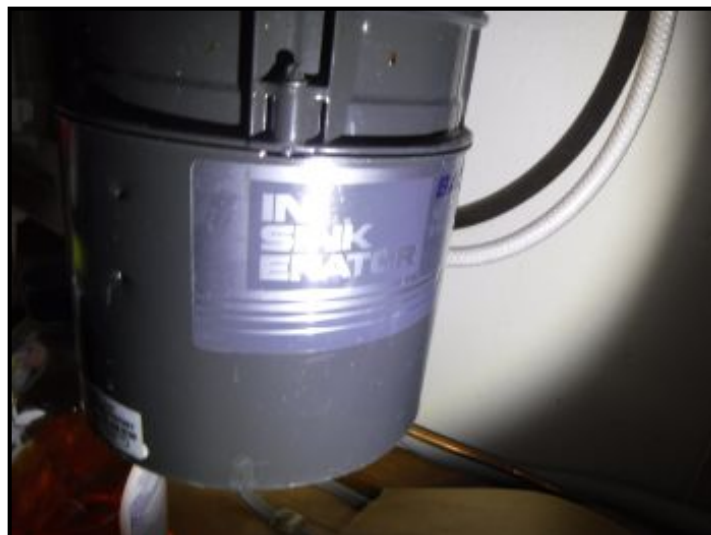
- Operated. Appeared functional at time of inspection.

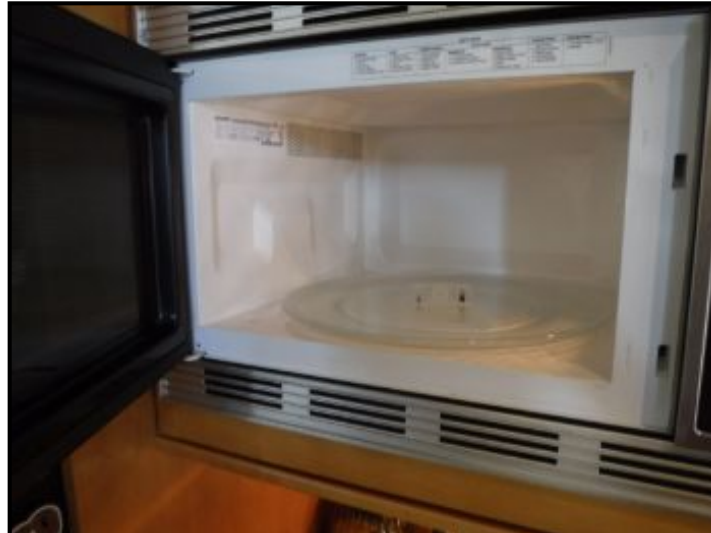
- Built-in microwave ovens are tested using normal operating controls. Unit was tested and appeared to be serviceable at time of inspection. Leak and/or efficiency testing is beyond the scope of this inspection. If concerned, client should seek further review by qualified technician prior to closing.

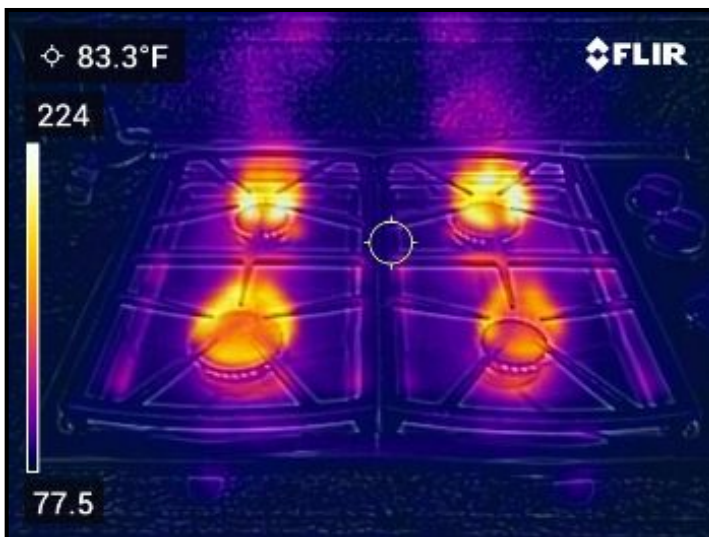
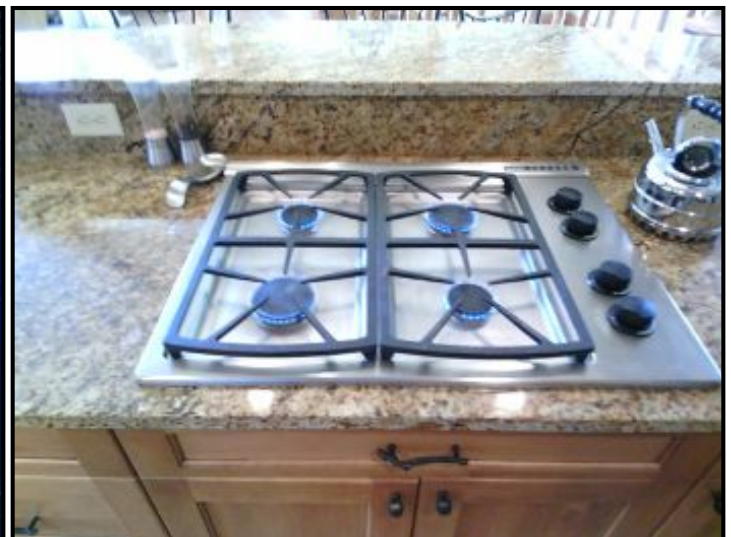
- Gas cook top noted.
- All heating elements operated when tested.

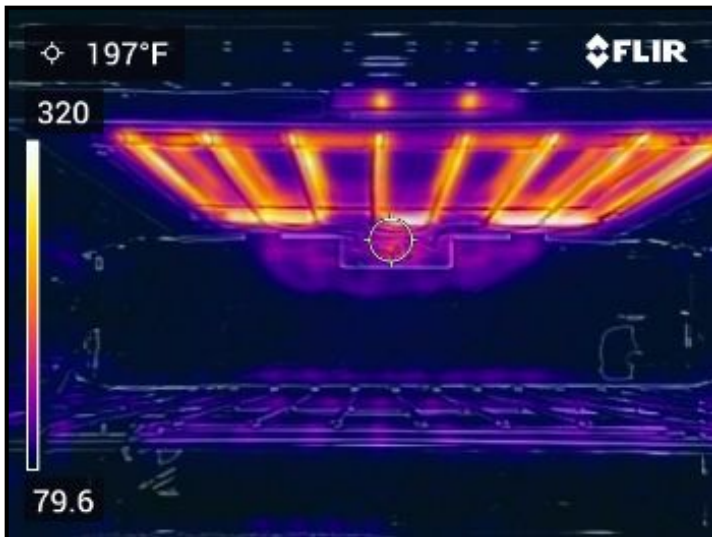
- Oven(s): Electric
- All heating elements operated when tested.

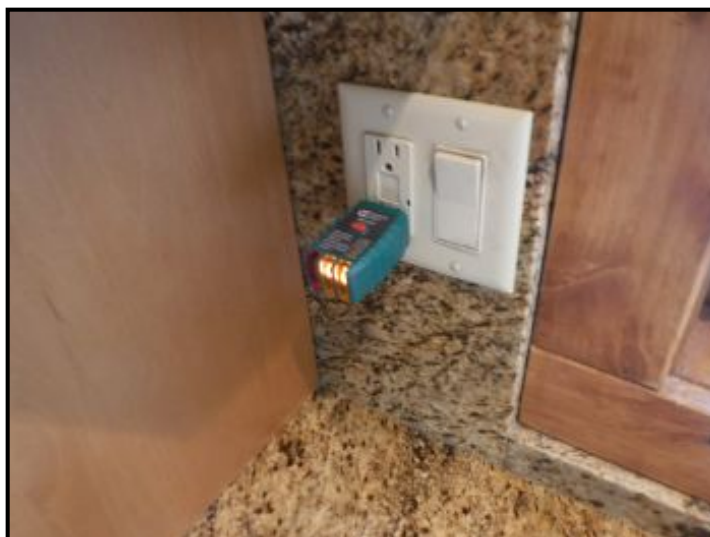
- GFCI in place and operational.

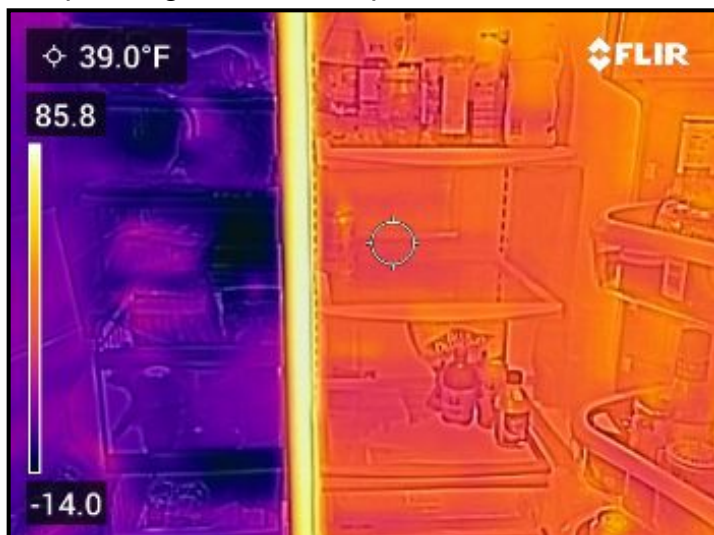
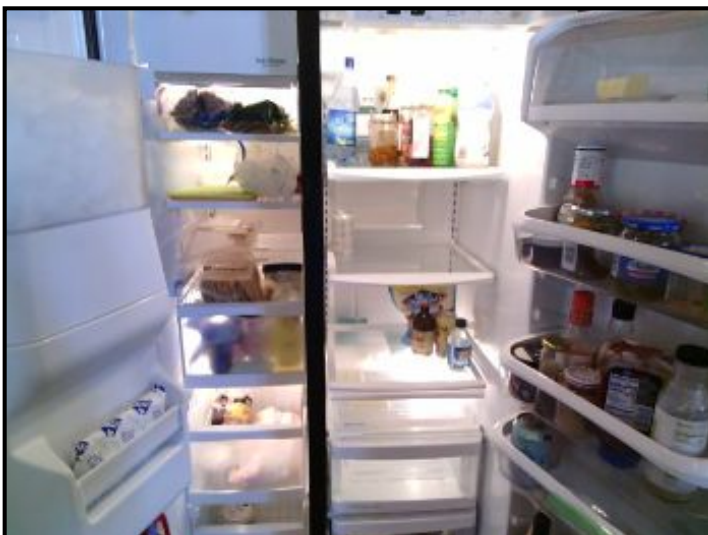
- Operating at time of inspection.

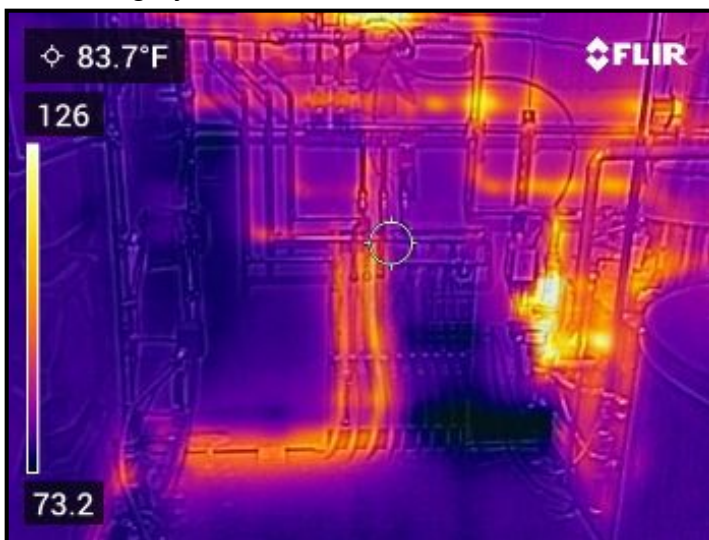
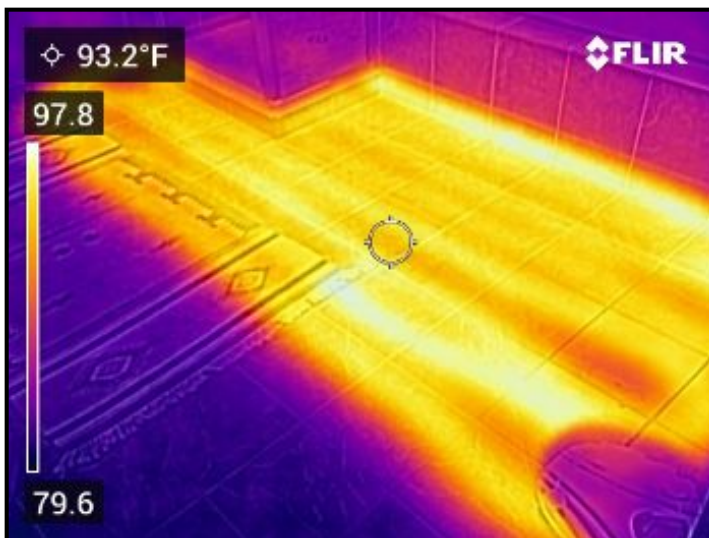
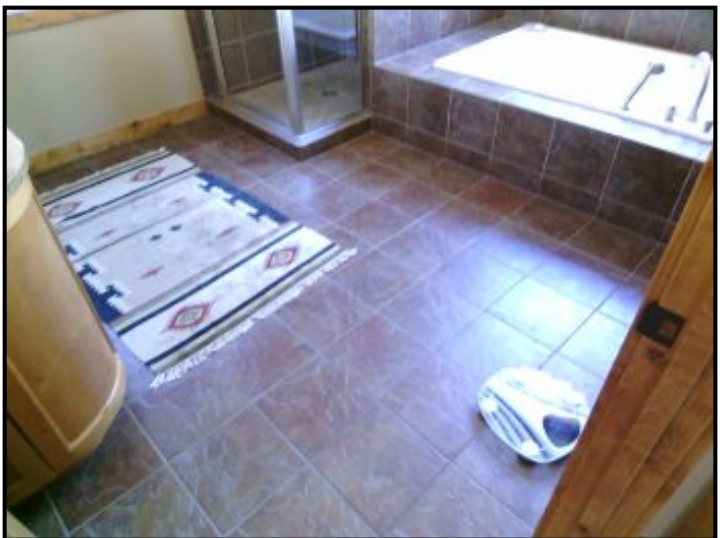
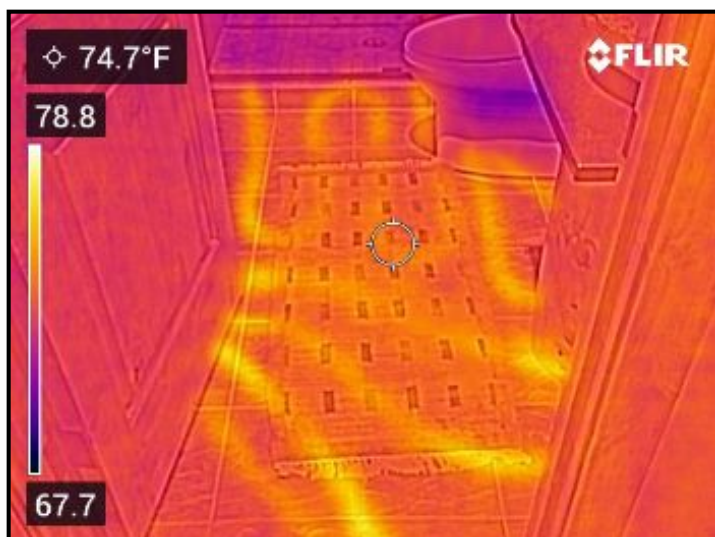
• Heating system was functional.

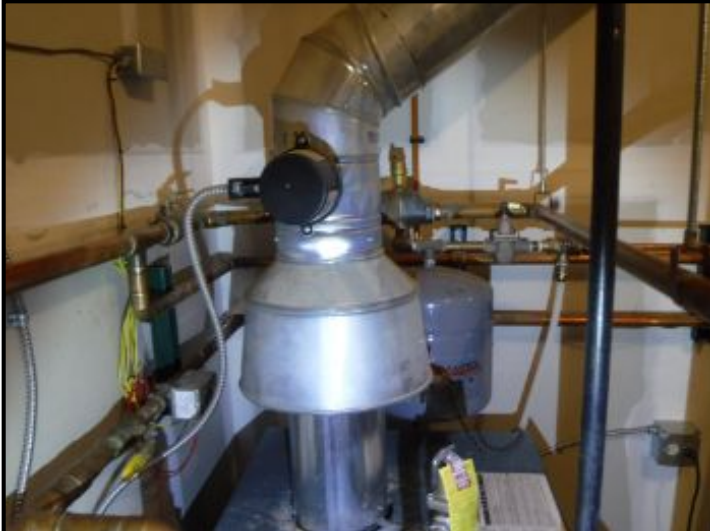
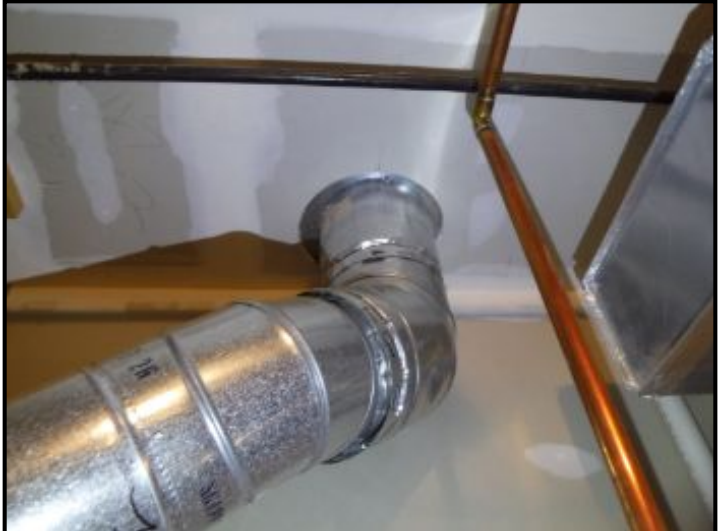
- **\*\*VENTING MATERIALS\*\***
- Metal double wall chimney vent pipe noted.
- **\*\*VENTING OBSERVATIONS\*\***
- The visible portions of the vent pipes appeared functional.

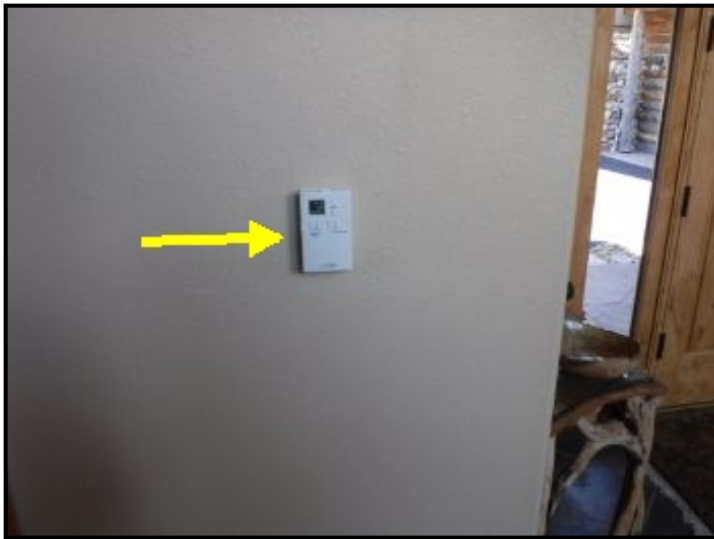
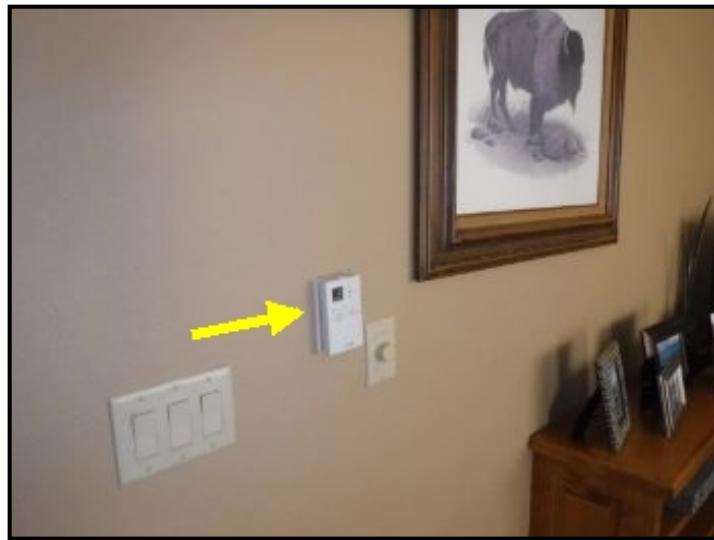
- Functional at the time of inspection.
- Multiple zones noted.

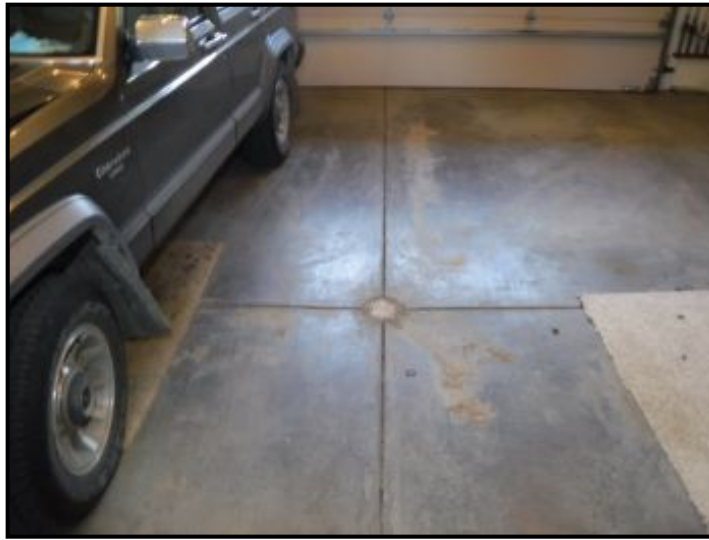
Materials: Bare concrete floors noted.

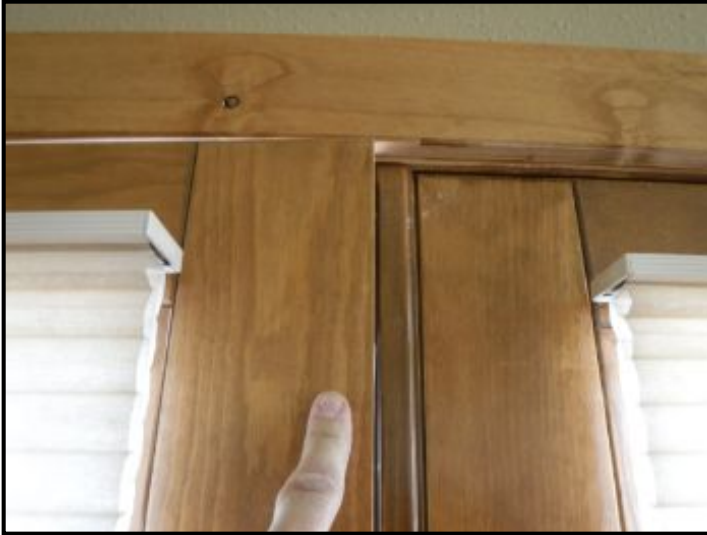
Lower level living room door was binding in the frame.

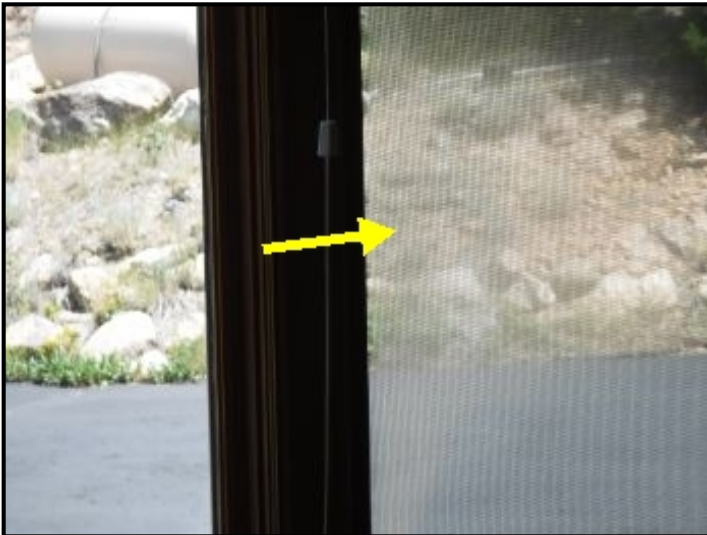
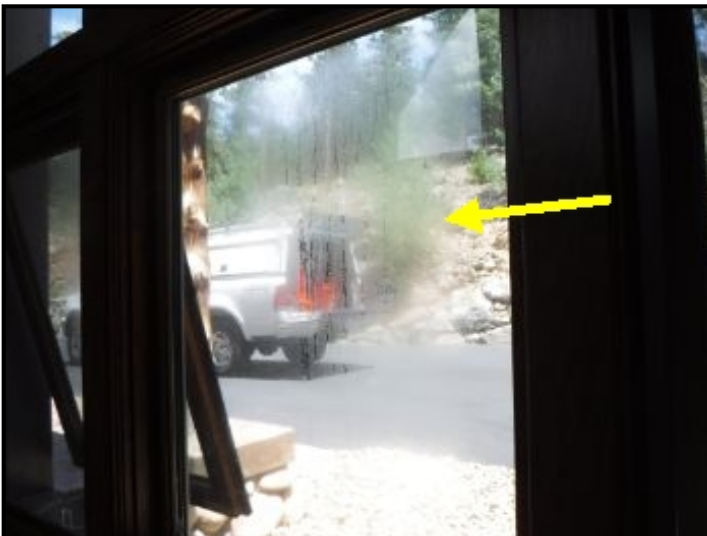
Condensation present in some double-paned windows, indicating a broken gas seal.

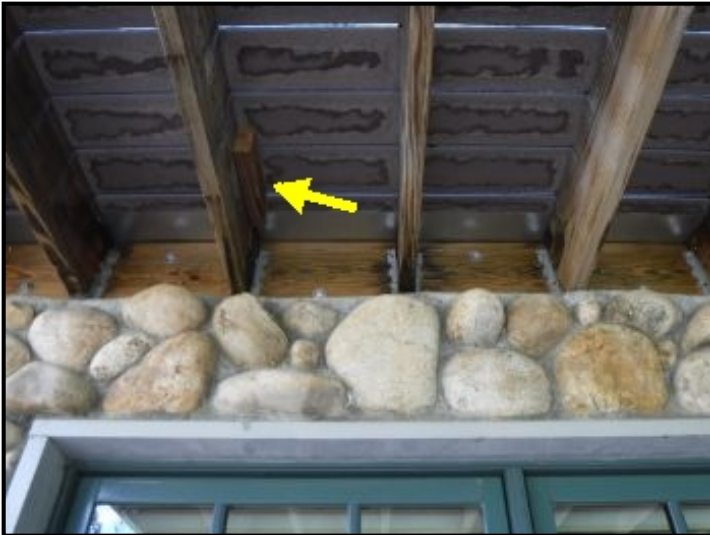
2" x 4" 's used to support deck boards that apparently have shrunk with time / reduced in length over time.

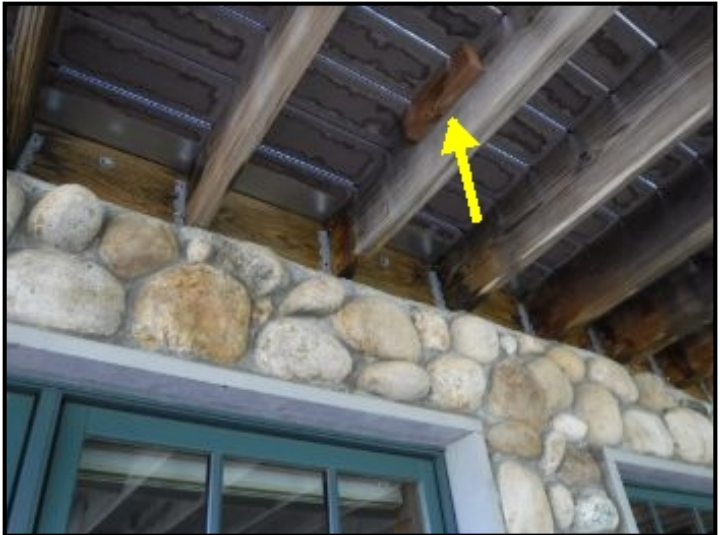
Deck boards had shrinkage.

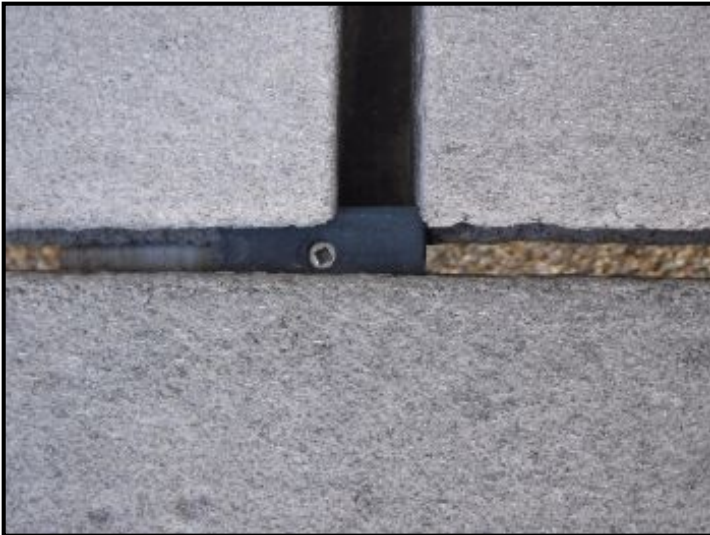
The composite deck boards were significantly deteriorated. Consider replacement of the deck surface.

Some deck boards were not secure.

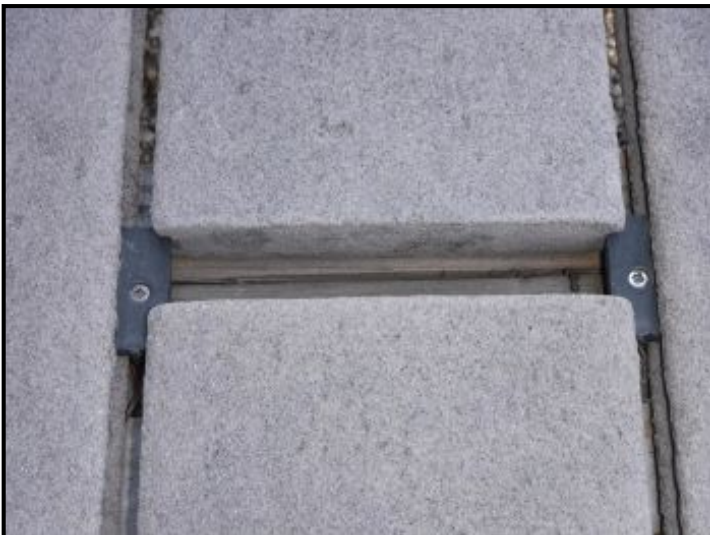
Decking was deteriorated.

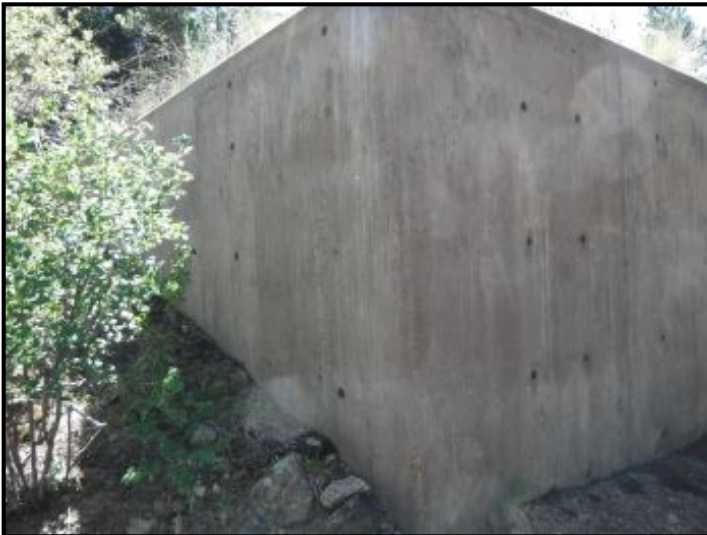
Septic system noted. Client is advised to seek the services of a specialist in evaluating this system.

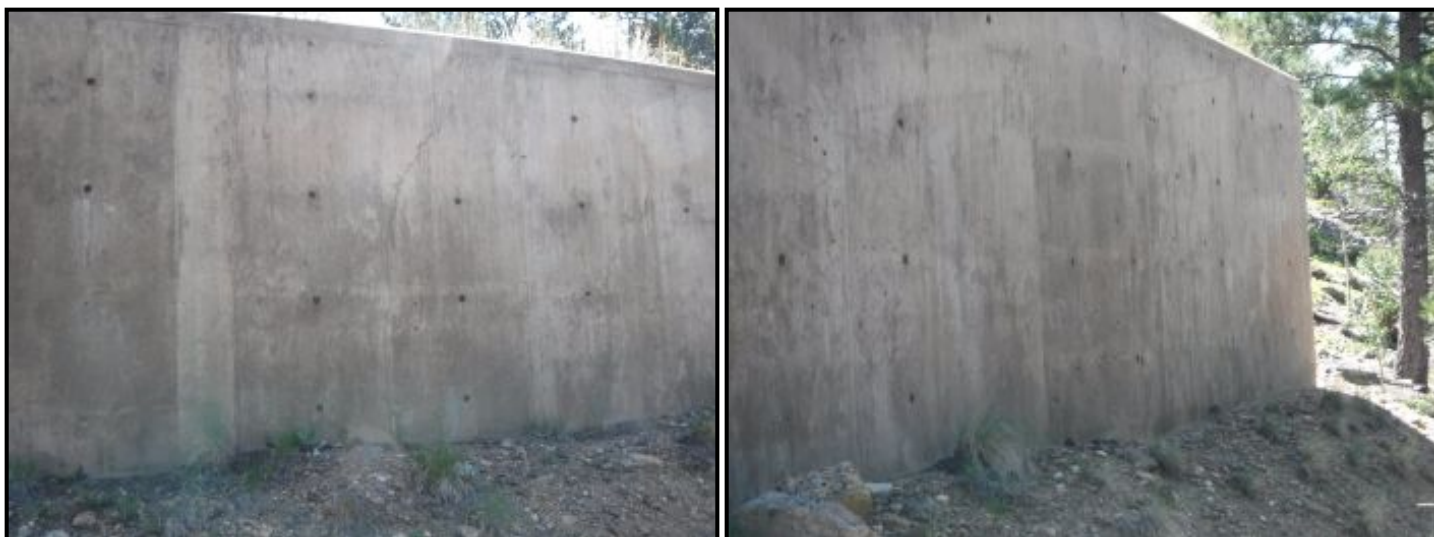
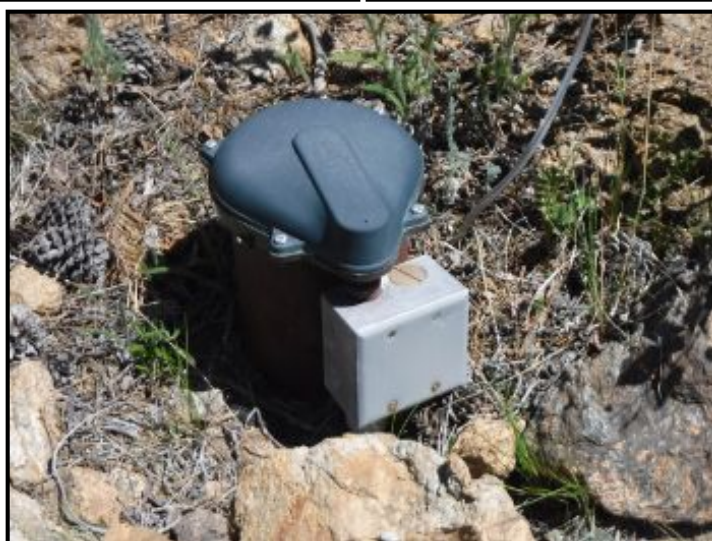
Potable water supplied by well. Suggest water testing within inspection contingency period.

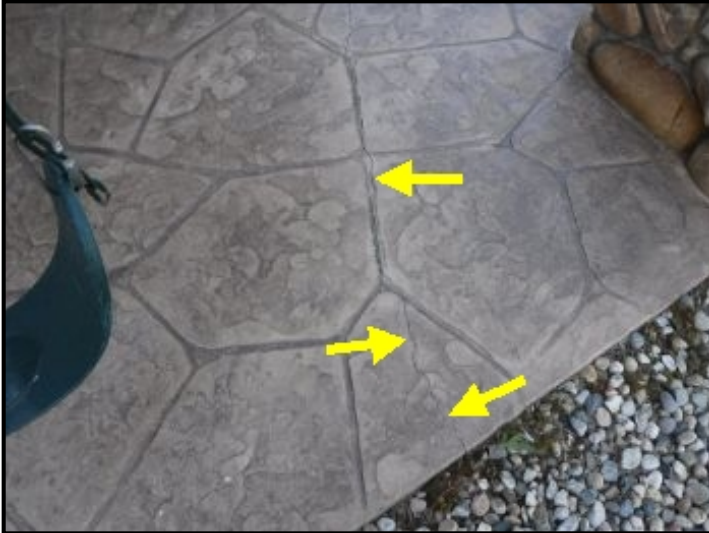
- No major system safety or function concerns noted at time of inspection.
- Concrete patio noted. No major issues.
- Concrete porch noted. No major issues.
- **Back/west patio: Settlement cracks noted.**

Back/west patio: Settlement cracks noted.

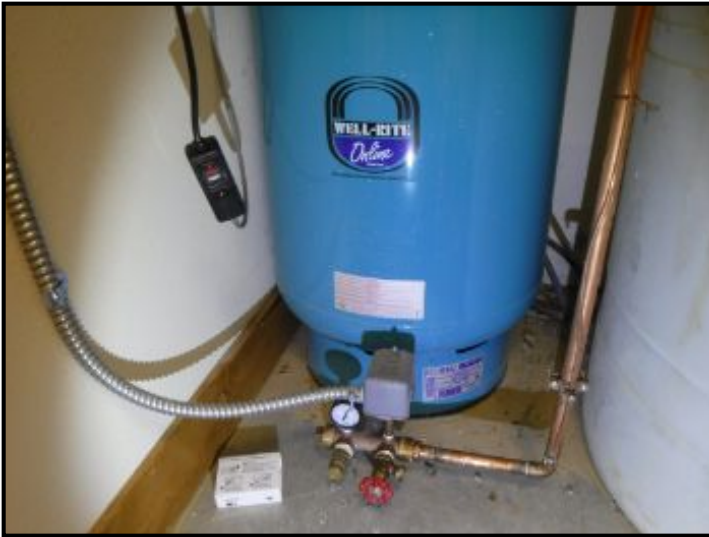
Pressure tank appeared functional.

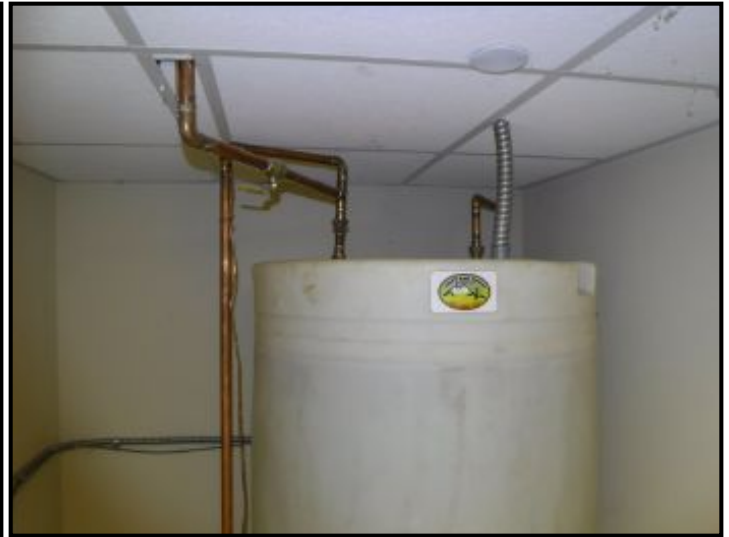
Water tank appeared functional.
